Re: Geotechnical Engineering Report
Henry Hudson Trail-Atlantic Highlands Section

TRC Engineers, Inc. (TRC) is pleased to present this report that summarizes our conclusions and recommendations regarding the impact of existing surface conditions on the future improvements to the Henry Hudson Trail. Our work was performed in general accordance with the Request for Proposal PS#10-14 and the March 13, 2104 purchase order number 60746. Specifically the scope associated with this report was identified as Item 2 in the Request for Proposal.

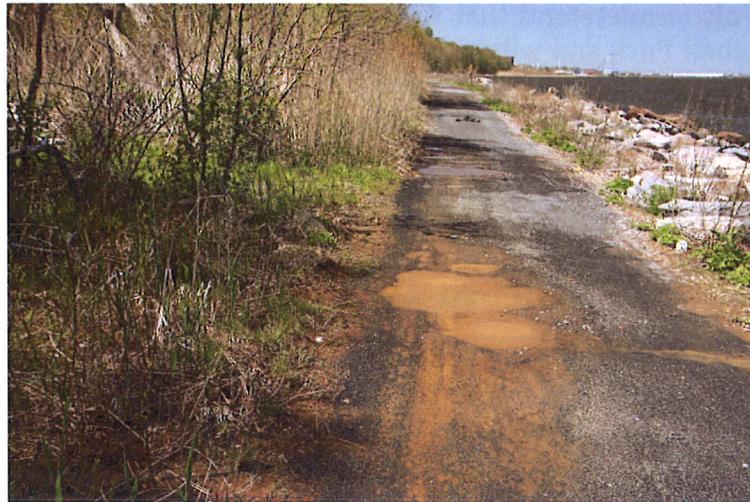
Typical Water Seeps Draining onto Trail

- b. Along the entire trail there is seepage from the existing slope toes that accumulates between the trail and slope resulting in ponding water which eventually flows over the trail. Along the trail there are many drain pipes that attempt to carry this water under the trail to the bay. However, due to the flat grades in a large number of cases the seepage which is not diverted to the drain pipes, subsequently flows over the trail. In some cases the ponding water could consist of septic seeps, based on the color and evidence of moldy organic growth. This ponding water can provide a breeding area for mosquitos. As evidenced during the January 2014 site visit this over trail seepage freezes on the trail resulting in a thick ice buildup that not only limits use of the trail but also results in trail deterioration.

- i. Probably the least expensive approach is to utilize small swales at the trail edge to intercept and divert seep water to existing or new cross-drains under the trail. These swales would unlikely change the surface water seep conditions beyond a few feet from the swale.

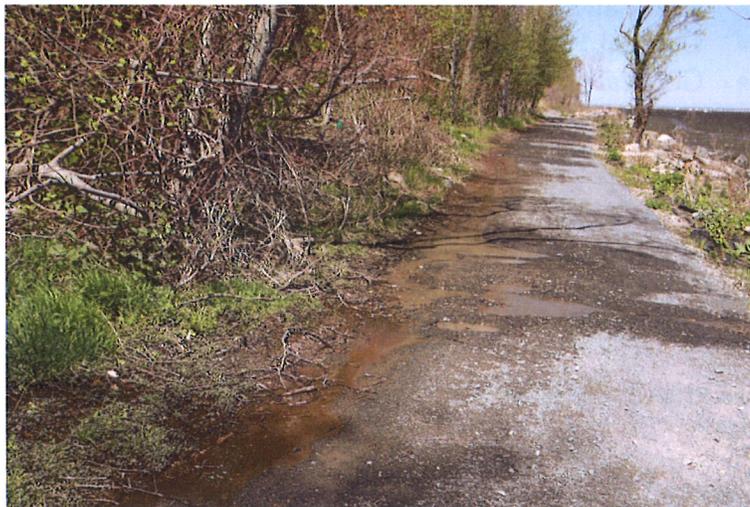
Typical Water Seeps and Trail Surface Erosion

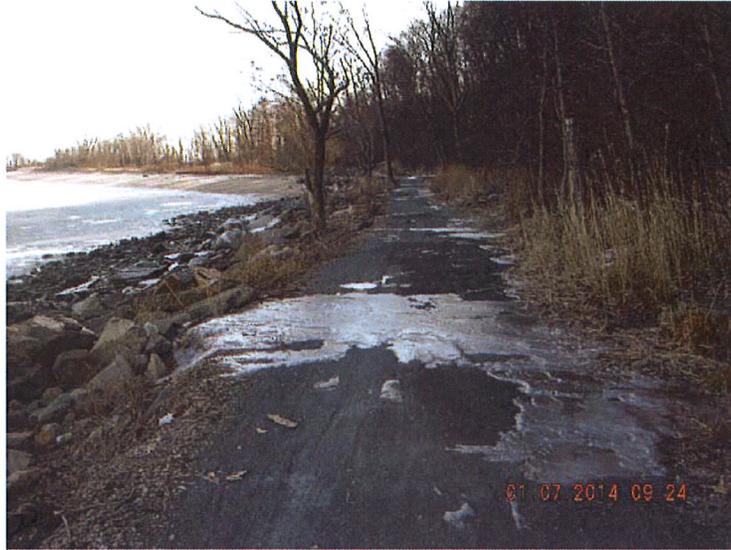
Ice Build-up on Trail from Un-diverted Seeps

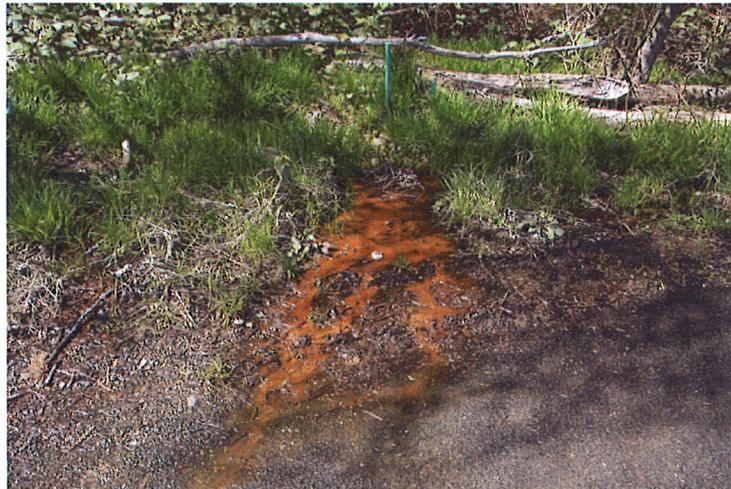
Iron-rich or Possible Septic Flow

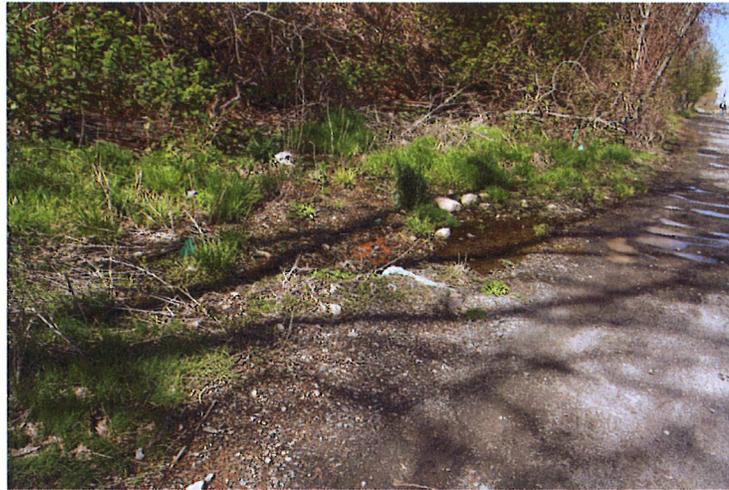
Water Seeps not Diverting to Cross-drain

- iii. Install additional cross-drains under the trail where needed.
- iv. In areas of existing wetlands install crossdrains but include a drop yard drain that would still maintain wet conditions for wetland growth but allow excess standing water to overflow into the cross-drain.

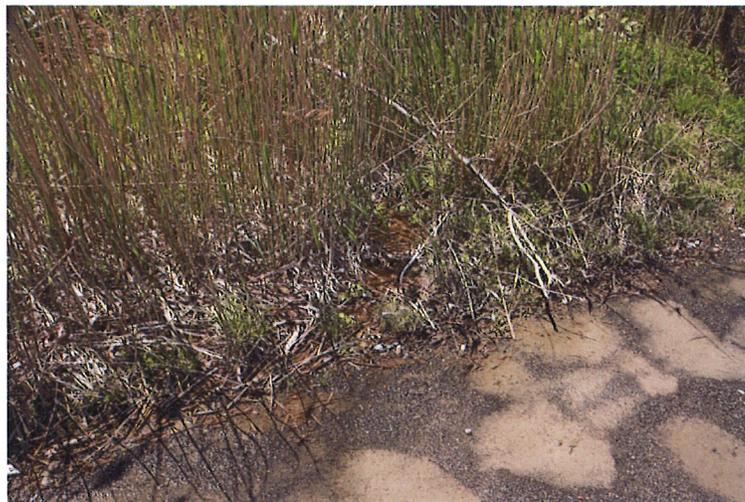
- c. There are some documented small wetlands between the trail and toe of existing bench slope that is likely the result of continuous seeps from the slope toe. In most cases the seepage water also flows over the trail.

Probable Wetland and Water Seeps

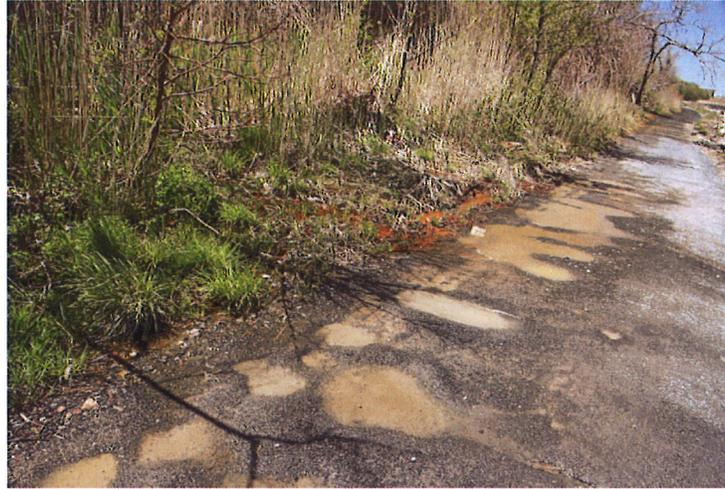
Un-diverted Water Seeps and Trail Surface Erosion

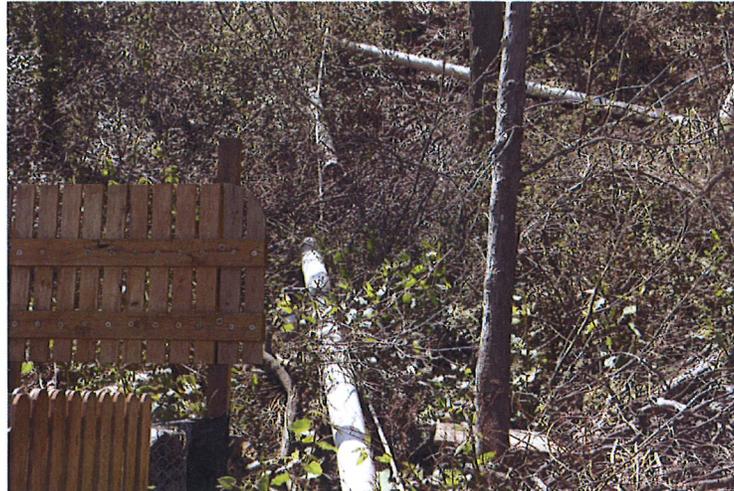
- d. There is evidence of many property owners draining rain water or other water from their property onto the existing slope or toe of slope by utilizing drain pipes. Some of these drain pipes are readily visible and some are buried in the vegetation near the toe of the bench slope. Continuous or sporadic water draining onto the slope could saturate the soils or erode surface material resulting in slope failures, as well as dumping water onto the trail.

Drain Pipes from Private Property

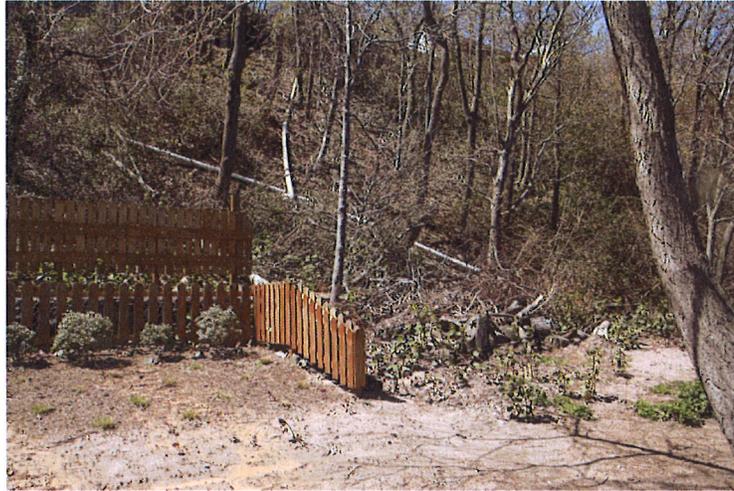
Drain Pipes from Private Property

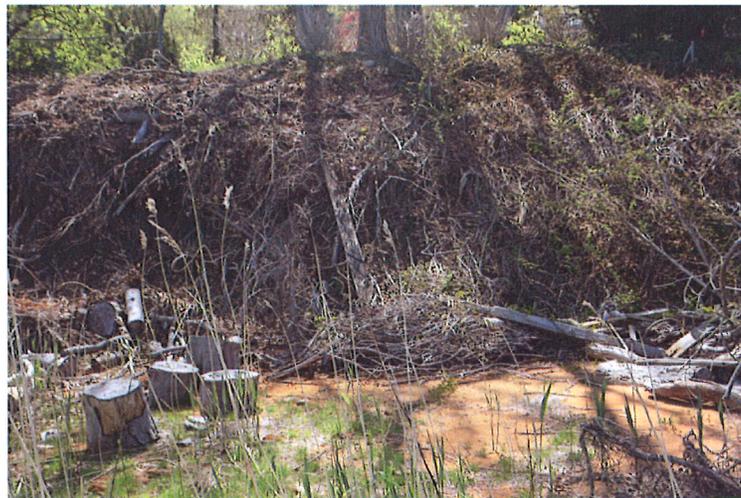
- e. Apparently the storm surge during Superstorm Sandy had eroded the toe of existing bench slopes of nearby private property or County property adjacent to the trail. This erosion resulted in near vertical scarps that in some cases are 3 to 4 ft tall and generally are non-vegetated. In many cases water seeps are evident from the toe of the slope that has been eroded. Continuous seeps could cause further erosion that could result in surficial slope failures, such as slides or mini-slumps.

Exposed Scarp due to Storm Surge Damage

Alternative stabilization measures for exiting County owned slopes which have eroded above the trail due to the Superstorm Sandy are provided to prevent further deterioration, local mini-slumps or surface slides.

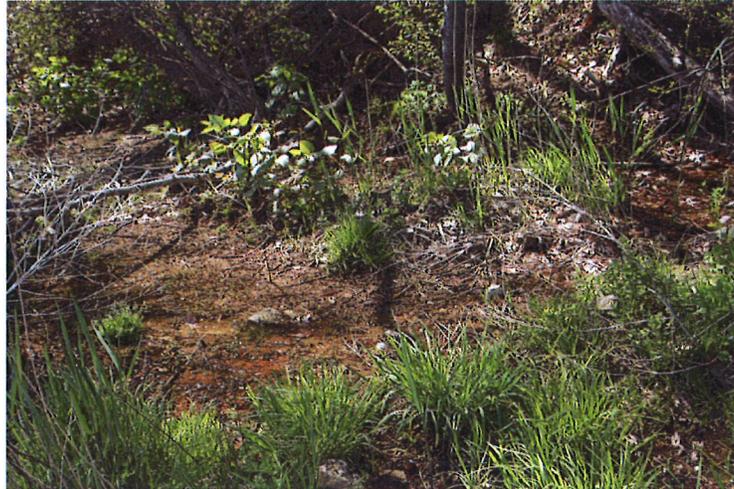
Typical Water Seep

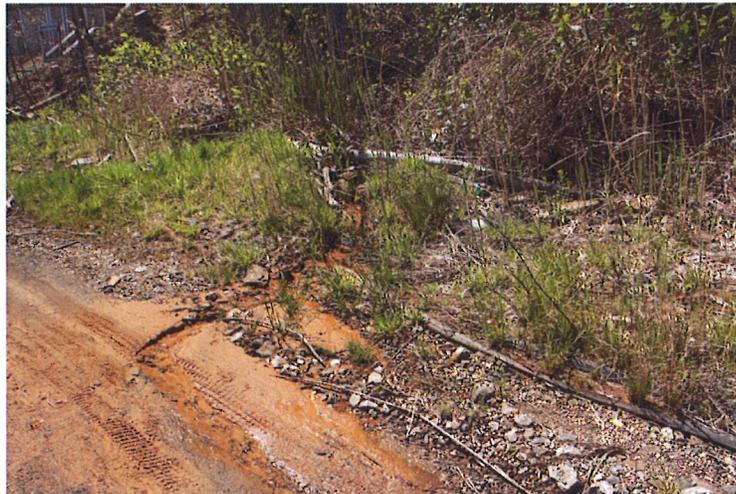
- f. Due to erosion from Superstorm Sandy, in many cases vegetation has not been fully restored and non-vegetated areas are subject to continuous erosion. Furthermore, in the area where the toe of the bench slope has been eroded, there are some small to large trees that are barely rooted and may be subject to further uprooting and falling onto the trail.

Un-diverted Seepage and Erosion

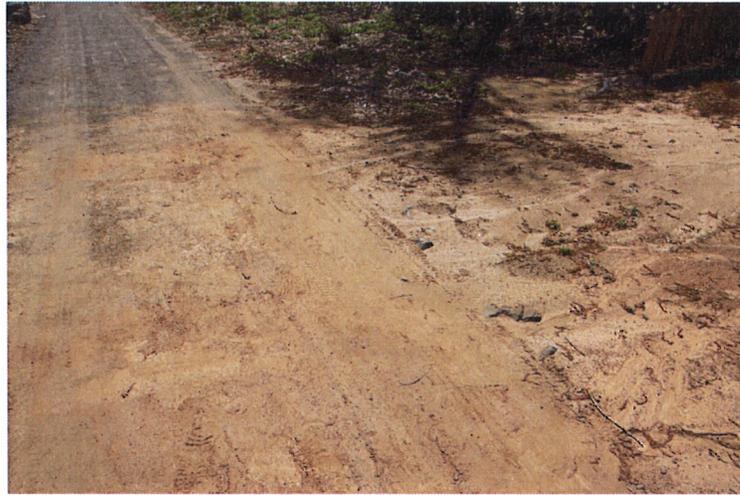
Surface Erosion Deposited on Trail

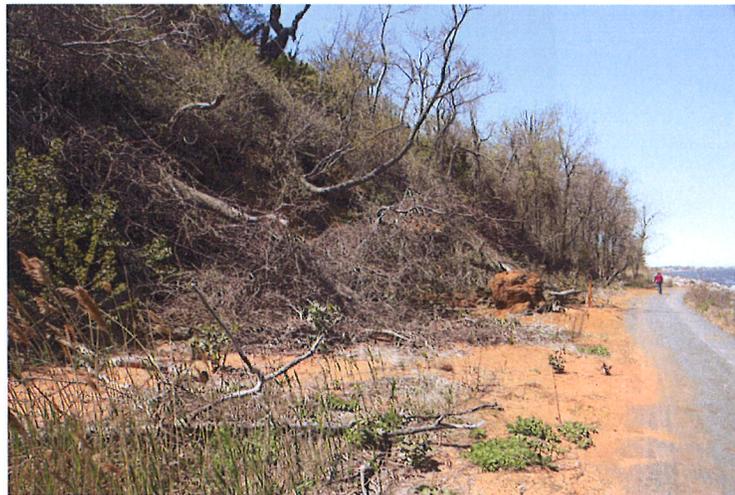
- g. One area of the adjacent bench slope consists of highly cemented iron rich sand that resembles sandstone. Large blocks of this material had separated from the slope. The remaining portion of the slope has large voids and fracture zones. With time some of the slope could be undermined resulting in additional blocks of this material breaking off the slope and tumbling onto the trail.

Cemented Sand Block Displaced from Upslope

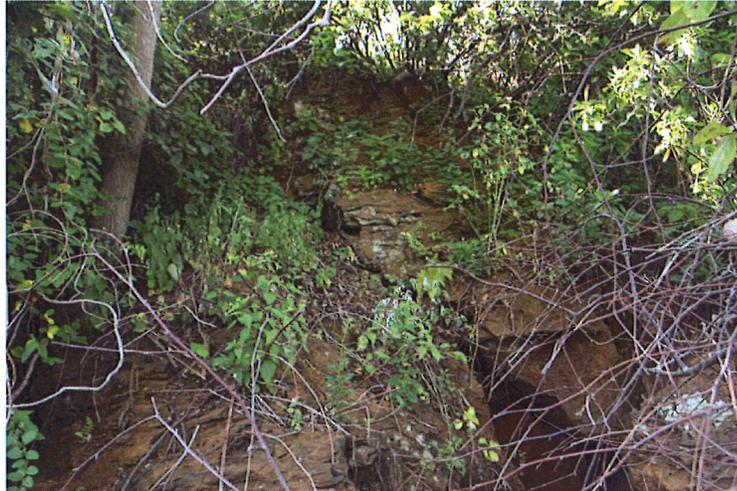
Cemented Sand Fractures and Voids

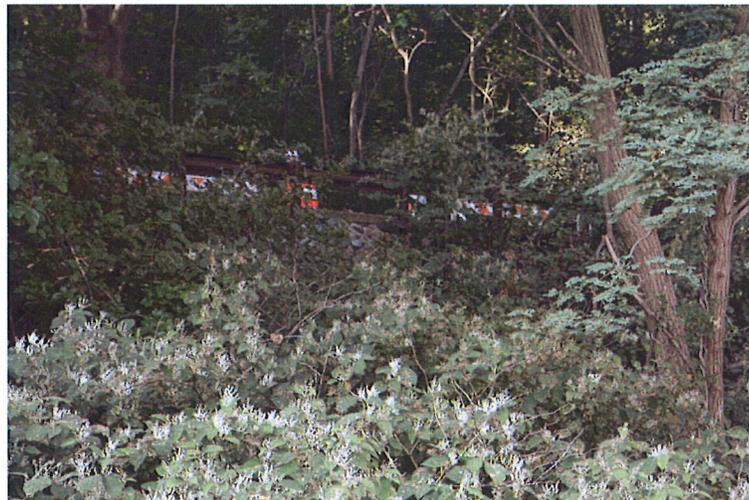
- h. There has been evidence of relatively recent slope failures above the trail. In one case loss of soil materials from the slope which began undermining Bayside Drive. Additionally, a more recent large soil slide probably in 2013 from below Bayside Drive exposed a very large non-vegetated portion and a slump of soil cover and vegetation deposited just above the trail. A similar slide occurred at 160 Ocean Boulevard in the spring of 2014 when after a significant rain event the soil slope including automotive tires slid down slope for a large distance and all the uphill material slumping onto the trail. Probably about the same time a min-slump failure occurred of a relatively short bench slope on what appears to be private property that deposited soil and vegetation materials on the edge of the trail.

Bayside Drive Affected by Slope Erosion

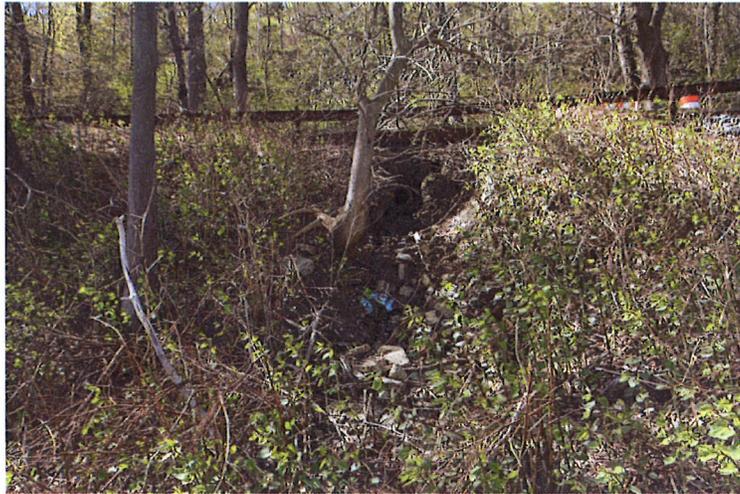
Slope Erosion below Bayside Drive

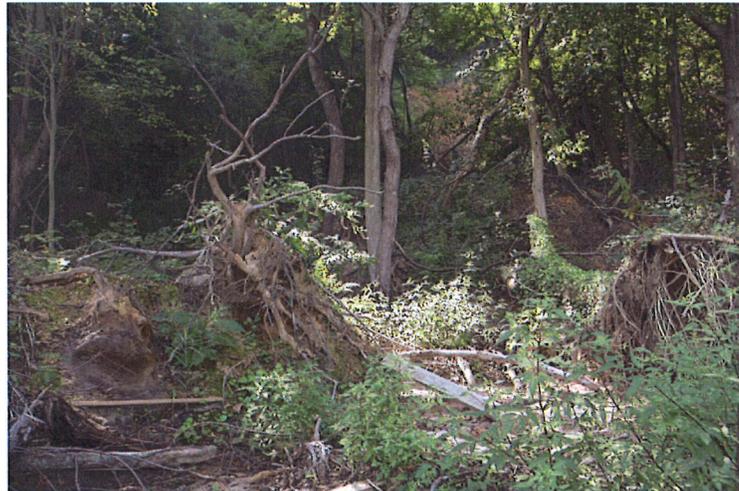
Relatively Recent Large Slide and Slump below Bayside Drive

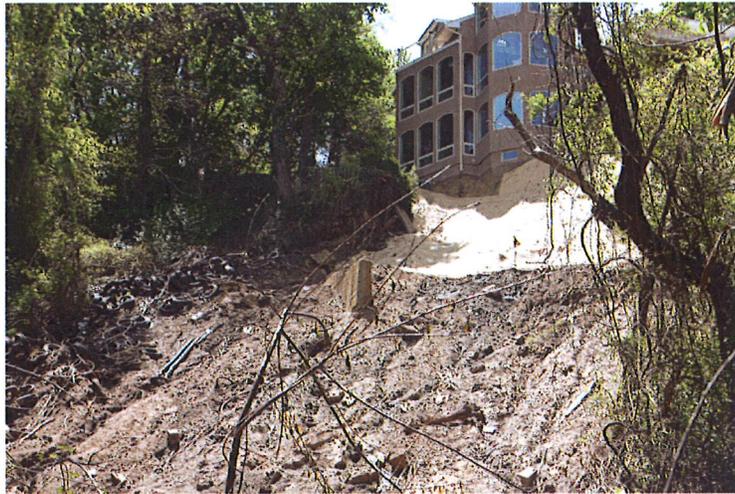
160 Ocean Boulevard Road Slope Slide- Tires Visible

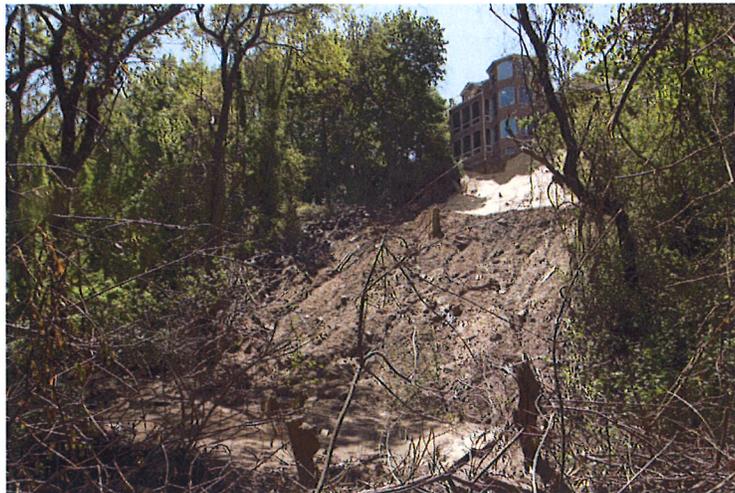
160 Ocean Boulevard Road Property Slope Slide

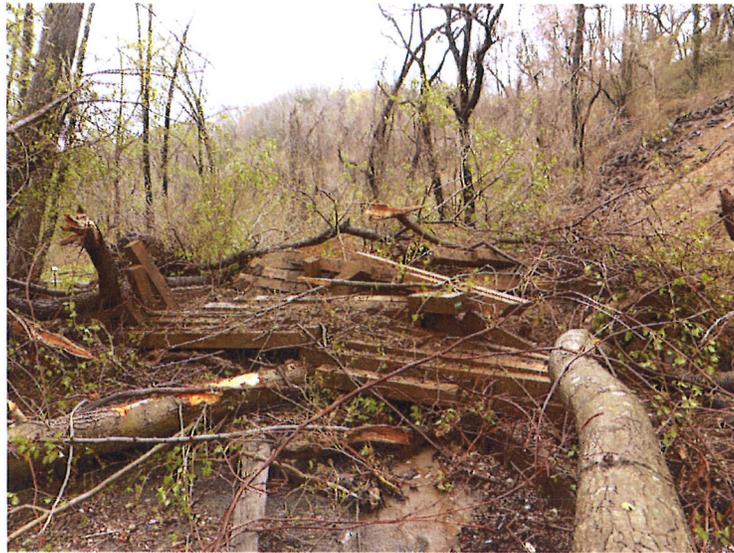
Debris on Trail from 160 Ocean Boulevard Property Slide

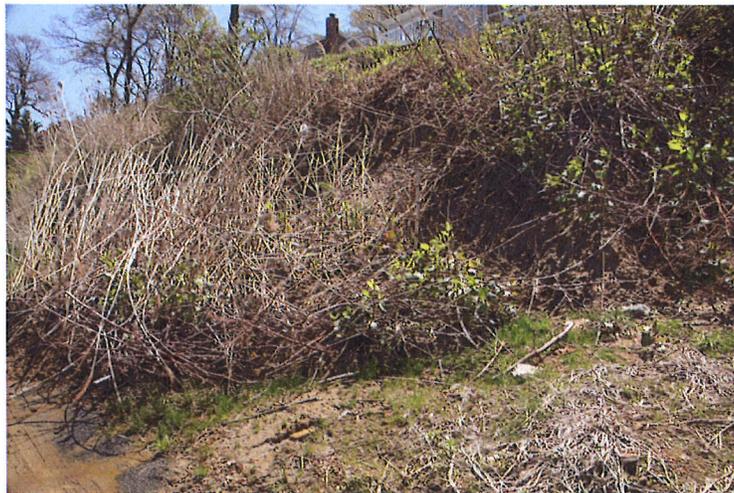
Mini-slump of Adjacent Bench Slope

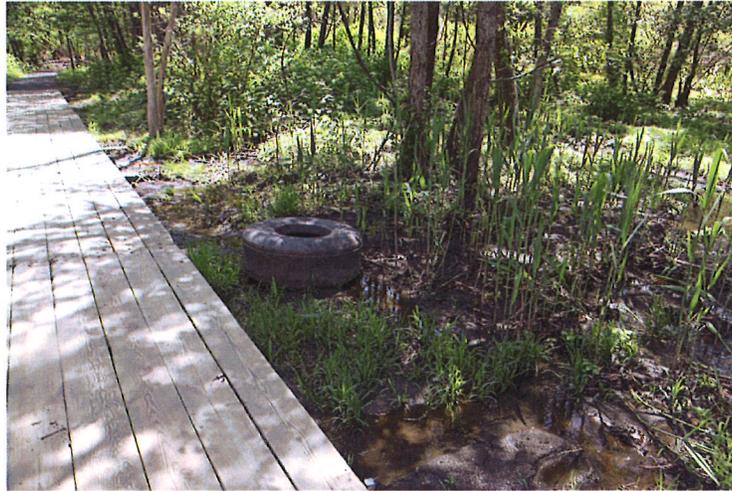
- i. Superstorm Sandy destroyed multiple wooden boardwalks and bridges that spanned small water sources or wetlands. It was noted that there is debris and tires in the wetland area. It was our understanding that most of the structures were supported on helical anchors.

Boardwalk over Wetland

Damage to the existing boardwalks and bridges as a result of Superstorm Sandy, limits use of the trail and such should be repaired, replaced or alternative approaches for such crossings could be considered.

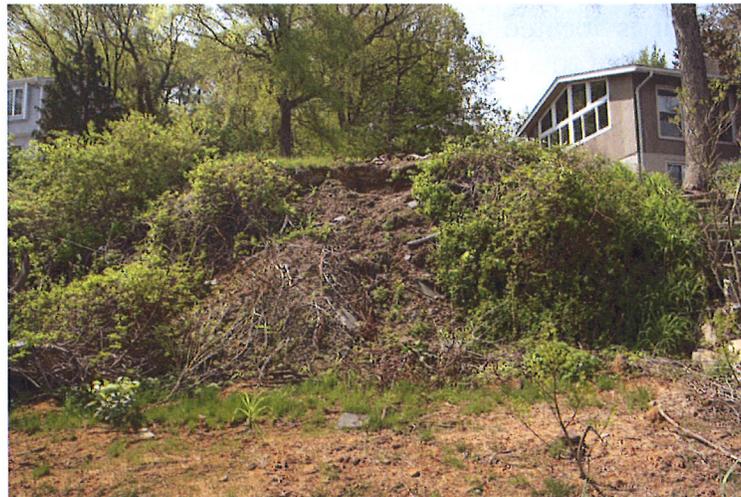
- j. There is evidence of various fill materials being dumped over the side of the benches by property owners. There is also evidence that some of this material has slid resulting in some of this material being deposited on or near the trail.

Movement of Fill Material Placed on Bench Slope

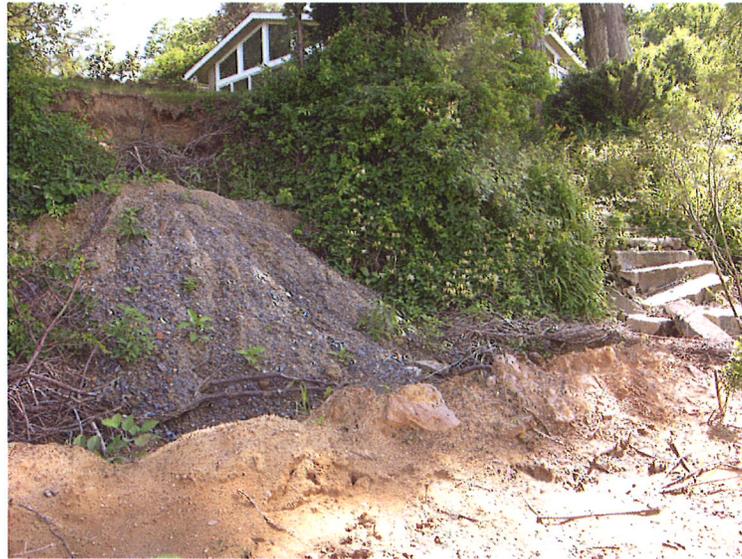
Movement of Fill Material Placed on Property Slope

In many cases private property owners dump soil or other fill material over the side of the bench for whatever reasons that could include stabilizing an eroded slope. Since this material is generally dumped and is relatively loose, it has a tendency to erode easily or slide subsequently depositing soil material near or onto the trail.

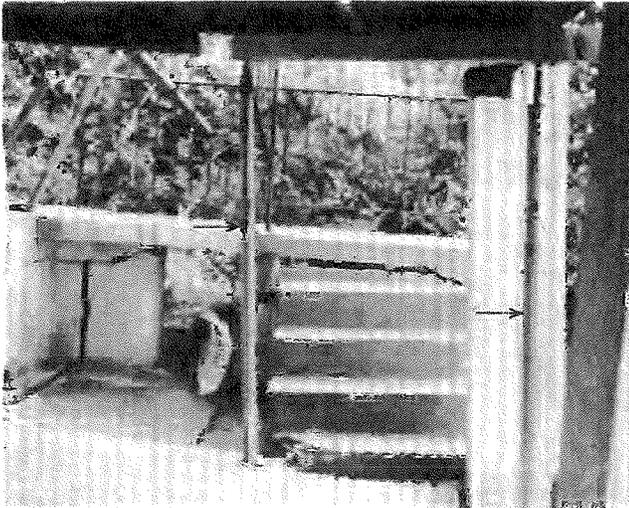
FIGURE 14.—House on wide eastern part of slump block B, straddling line of failure between subsidiary blocks B 1 and B 2, looking west. Settlement since summer 1972 has been more than 25 cm (1 ft). Note two jacks (arrows) holding up rear part of house. Photograph taken June 7, 1973.

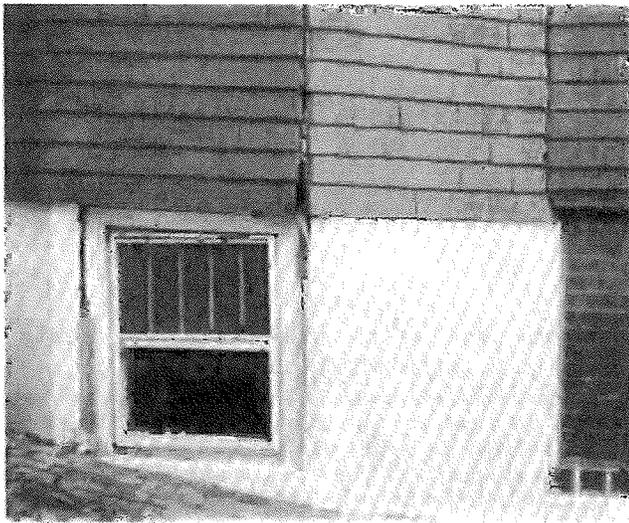
FIGURE 15.—Next house west of one shown in figure 14. Major structural damage to house results from its position astride the line of failure between slump blocks B 1 and B 2. Settlement and breakage goes all the way through the house. Photograph taken June 7, 1973.

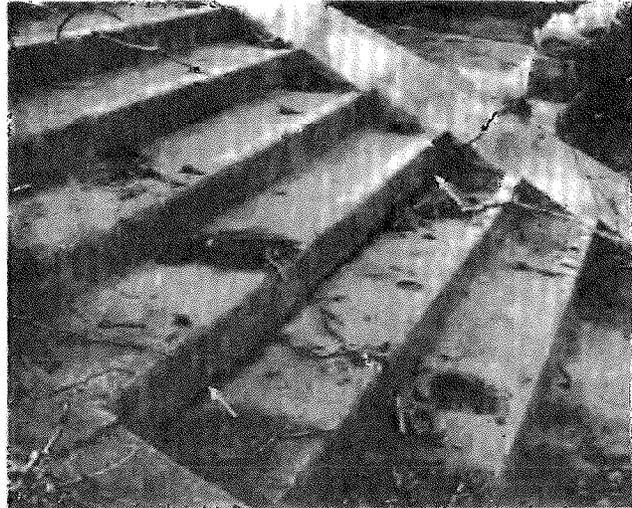
FIGURE 16.—Breakage in concrete steps (see arrows) on the western part of slump blocks B 1 and B 2 (fig. 2). The steps were reported unbroken in late fall 1973. Photograph taken January 25, 1974. First slumping and ground breakage on the blocks were reported during the summer of 1972. This indicates observable movement continuing over a period of 15 or 16 months.

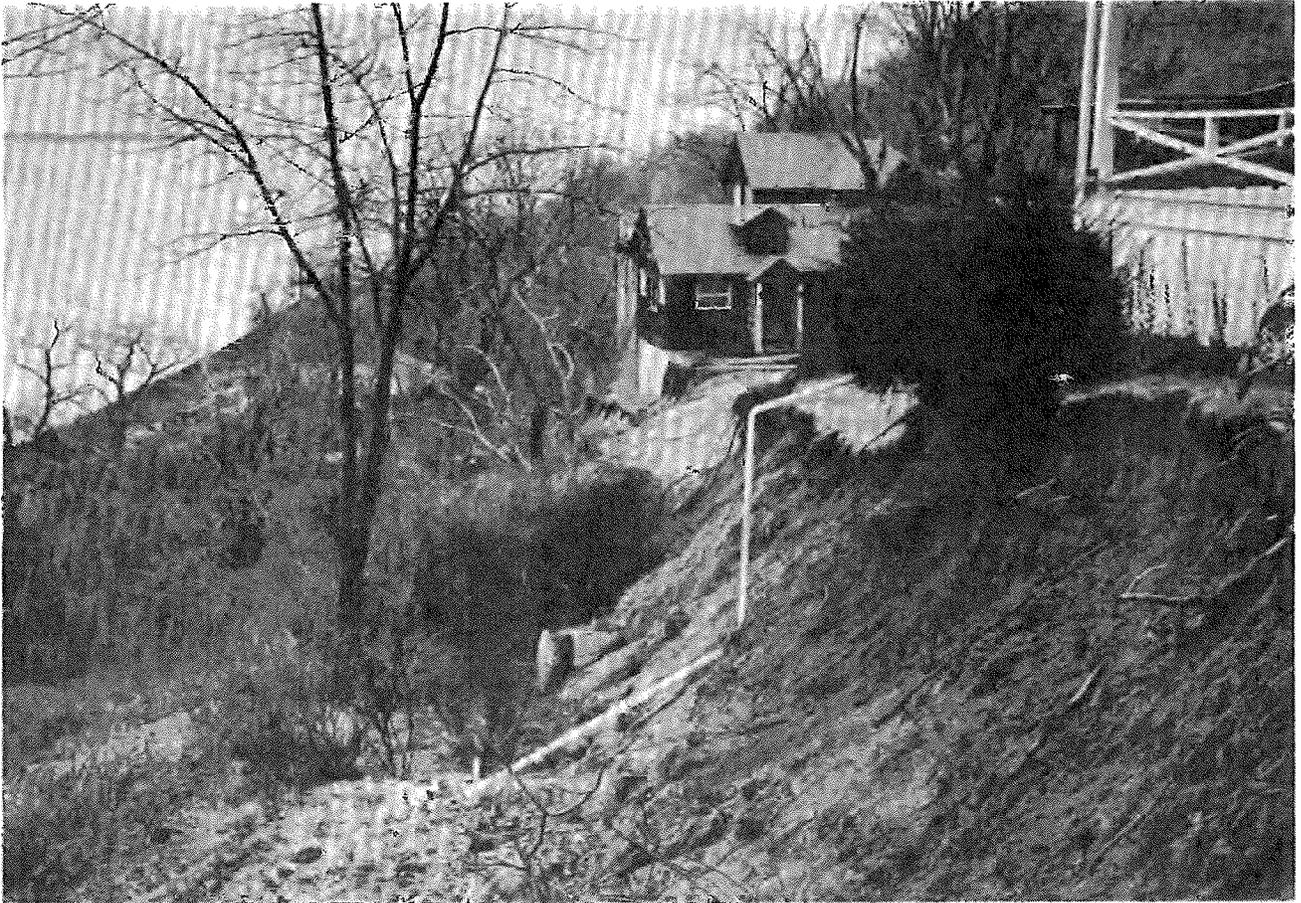
FIGURE 17.—Looking east from the west end of slump block B 3. Scarp on right is rupture zone at top and rear of the block. Total vertical displacement is about 4 to 5 m (13 to 16 ft), most of which is reported to have occurred during a 3-month period in the summer and fall of 1972. The flat grassy area at bottom left was level with the lawn at upper right before failure. Photograph taken January 24, 1974. House in background is shown in figure 18.

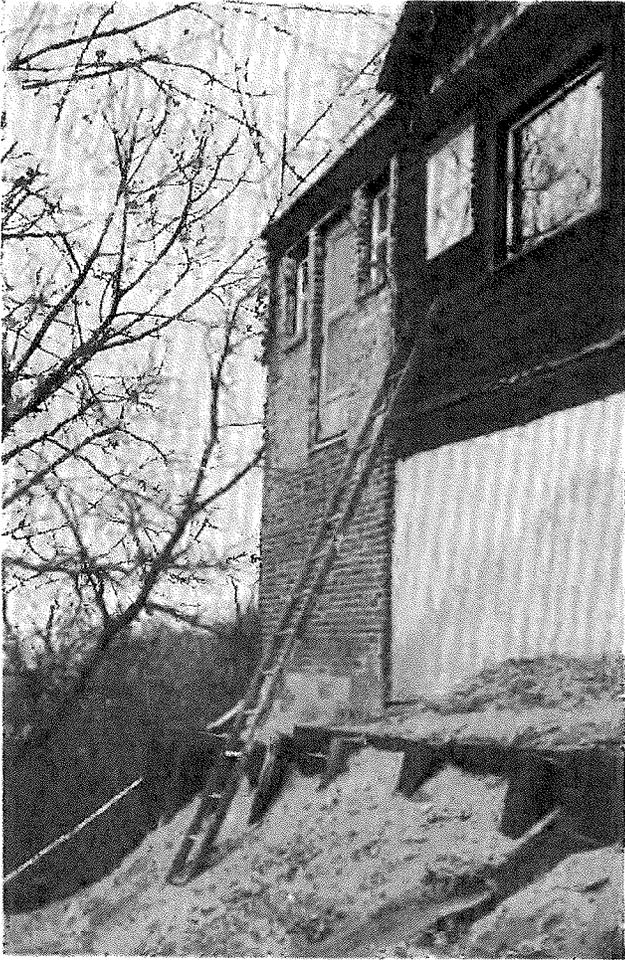
FIGURE 18.—House near east end of bank above block B 3, looking east. This is the house in the background of figure 17. The rear porch, which was attached to the house, collapsed when block B 3 dropped. Note position of door (watch that step!). Photograph taken January 24, 1974.

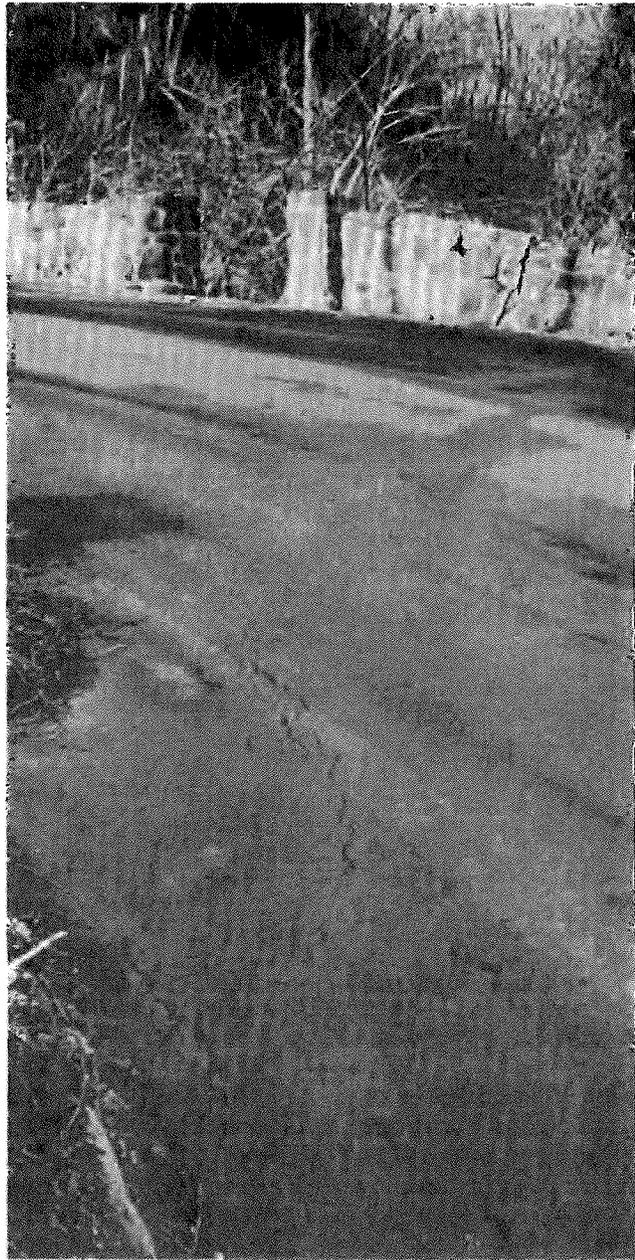
FIGURE 19.—Cracks in pavement of road and in wall at west end of block B 1 (block B as mapped in 1963-64 (Minard, 1969, pl. 1)). No cracking was visible when field mapped. Cracking was visible June 7, 1973, in parts of the pavement and wall. When this photograph was taken on January 25, 1974, cracking had multiplied and extended across the road, and the cracks were wider in the wall. Vertical displacement was as much as 6 to 8 cm (3 in.) in the pavement near the far side of the road.

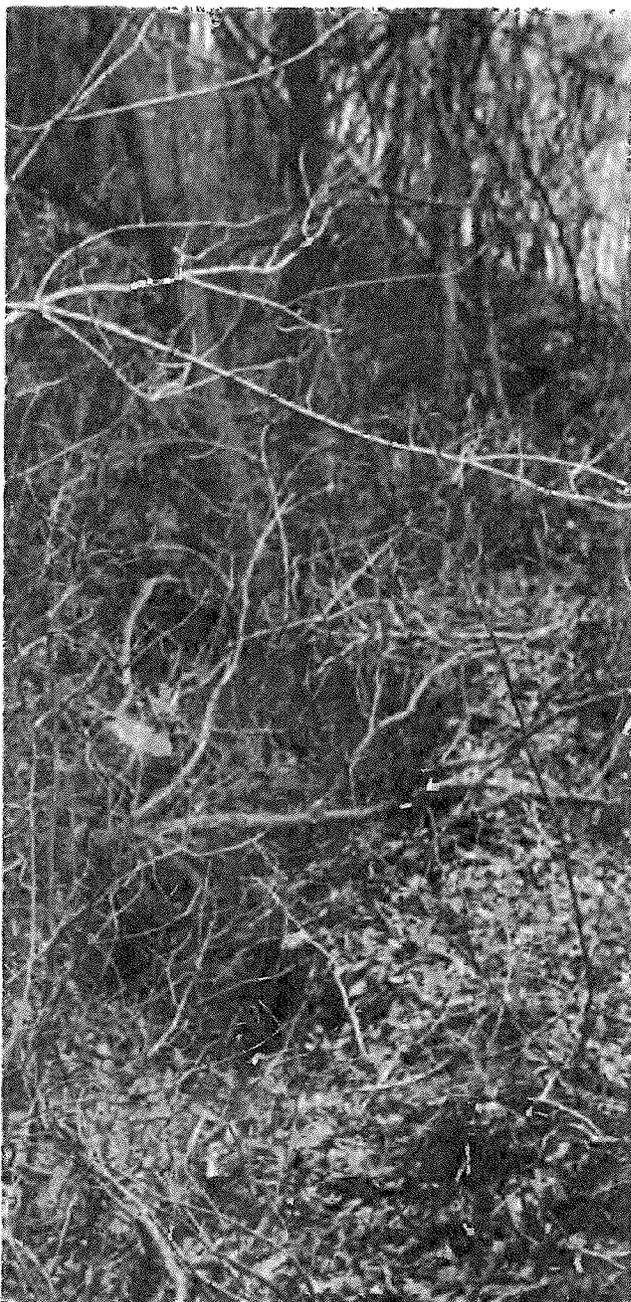
FIGURE 20.—View towards west of a fissure 1 m (several feet) and more deep, separating blocks B 3 and B 4. The fissure is several tens of metres long. Note tilt of tree caused by collapse into fissure.

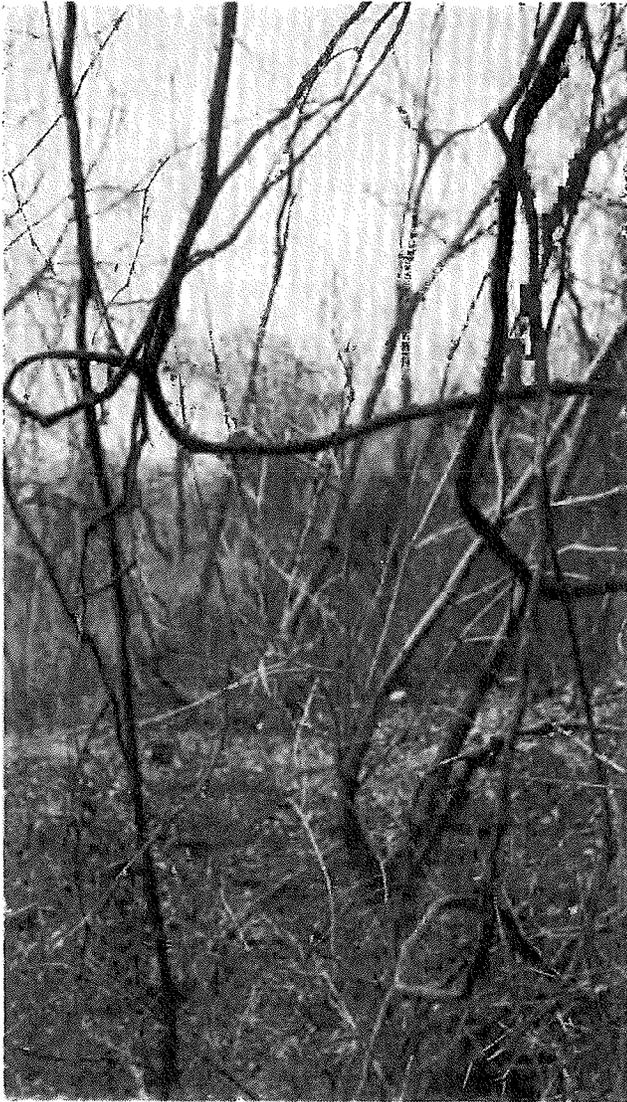
FIGURE 22.—View toward east showing tilted inner surfaces of block B 4 where slumped down from block B 3. (right of photograph). Notice that trees are tilted scarpward, illustrating rotational nature of the block; some vines appear to be stretched taut.
