# Slump Blocks in the Atlantic Highlands of New Jersey

By JAMES P. MINARD

GEOLOGICAL SURVEY PROFESSIONAL PAPER 898

*A description of slump blocks and slumping  
in the hills of the northeastern  
New Jersey Coastal Plain, and a  
discussion of their potential  
as geologic hazards*

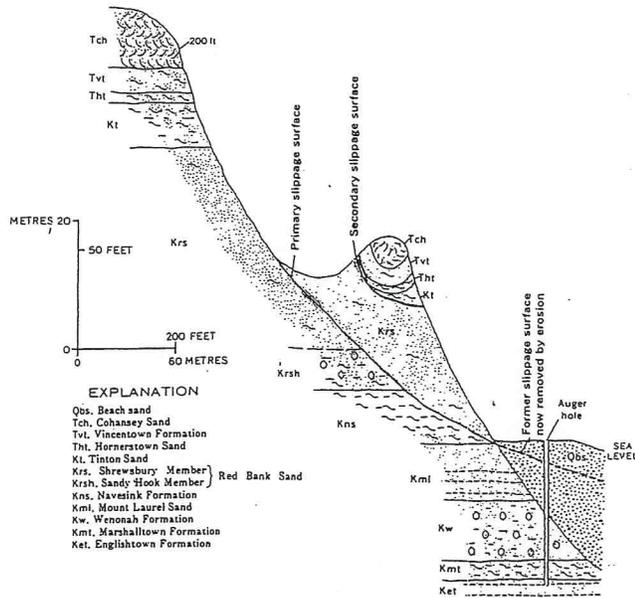
FIGURE 7.—Cross section (looking west) of slump block A in the bluff just west of Waterwitch (fig. 2). Vertical displacement of the small secondary block is about 85 feet. Vertical exaggeration  $\times 4$ . See figure 3 for explanation of lithologic symbols. Modified from Minard, 1969, figure 13.

The block has a secondary line of failure and slump block (A 2) near the middle of its cross section (fig. 7). The beds in block A 2, which originally were continuous with the beds at the top of the bluff 26 m (85 ft) above, have rotated from a nearly hori-

zontal attitude to about  $40^\circ$  inward and have been dragged on the inner surface to nearly  $40^\circ$  outward

(fig. 7). The primary (inner) slumping apparently was bottomed in the basal member of the Red Bank Sand and Navesink Formation. Secondary slumping was largely in the upper member of the Red Bank Sand. As can be seen in figure 2, several houses have been constructed on the block. A sand pit is present, from which much material has been removed in the past decade. This probably is beneficial in that it has taken much load off the block. It was in the sand pit that excellent exposures of the different lithic units made it easily possible to correlate these units with those from which they were separated in the bluff 26 m (85 ft) above.

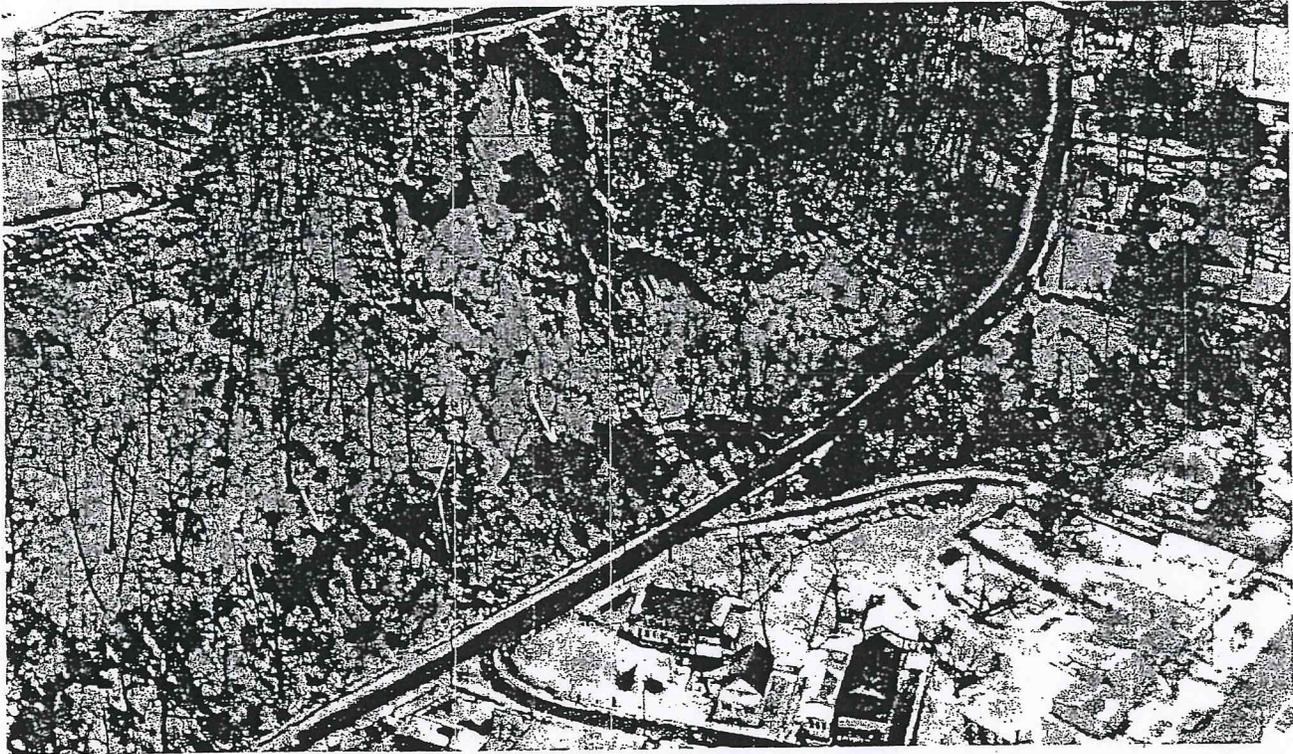
February 1974 (fig. 13). The gully in the scarp above and near the west end of block A is much deeper and wider at present than it appeared on the stereoscopic pair of aerial photographs taken in 1961 (fig. 11).

FIGURE 13.—Oblique aerial (helicopter) photograph (looking west) showing extent of surface erosion on the bluff face (center of photograph) on February 13, 1974. Vertical distance from road at top of bluff to road at base of bluff is about 60 m (200 ft). Inner part of slump block A is at far right; scarp is above and left of it. Compare extent of slope erosion with that shown on figure 12, nearly 8 years earlier. Erosion has extended upward, nearly undercutting the road, and laterally. Erosion has cut back into the face of the bluff, as is indicated by the steeper banks bordering the edges of the scar.

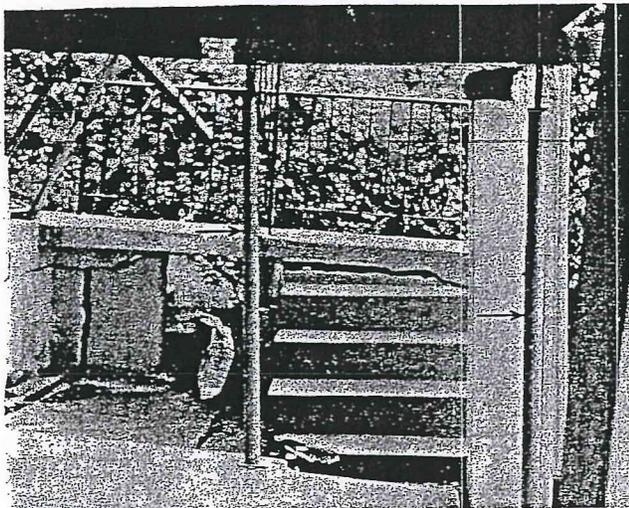
dle of this block, several houses and properties are being adversely affected by the slumping. Two houses have been damaged (figs. 14, 15), largely through vertical displacement of as much as 0.3 m (1 ft). An open crack passes in back of two more houses. This crack has been open as much as 20 cm (8 in.) wide and 1 to 1.3 m (3 to 4 ft) deep. At least one stone wall has been cracked completely through. West of here, concrete steps leading down to the shore are conspicuously cracked all the way across; the upper more pronounced crack is shown in figure 16. According to Mr. Edward Weiler (oral commun., January 25, 1974), the steps were not cracked in the fall of 1973.

FIGURE 14.—House on wide eastern part of slump block B, straddling line of failure between subsidiary blocks B 1 and B 2, looking west. Settlement since summer 1972 has been more than 25 cm (1 ft). Note two jacks (arrows) holding up rear part of house. Photograph taken June 7, 1973.

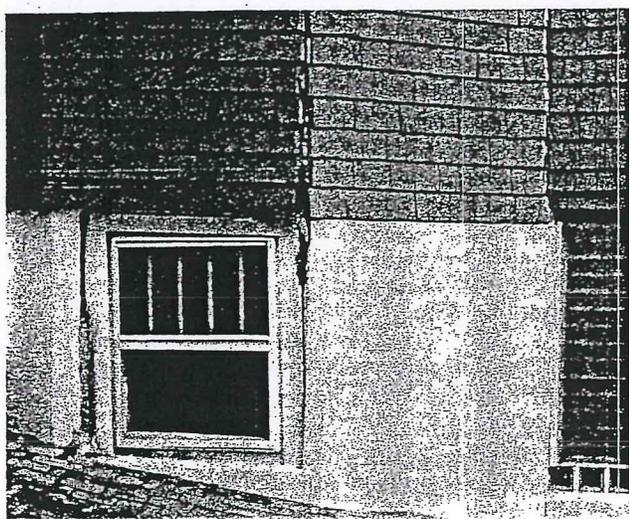
FIGURE 15.—Next house west of one shown in figure 14. Major structural damage to house results from its position astride the line of failure between slump blocks B 1 and B 2. Settlement and breakage goes all the way through the house. Photograph taken June 7, 1973.

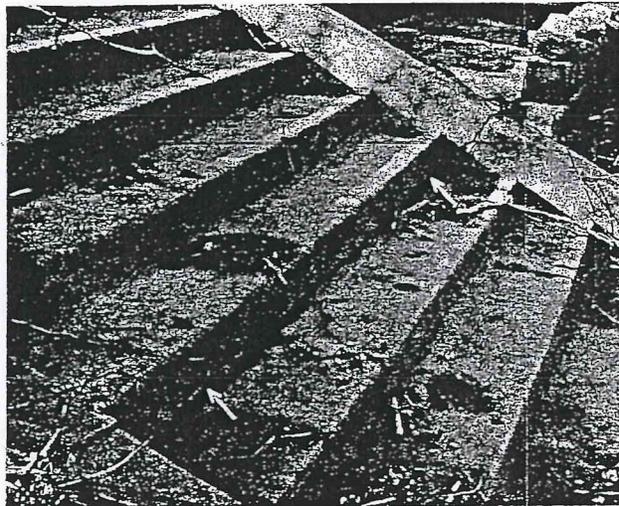
FIGURE 16.—Breakage in concrete steps (see arrows) on the western part of slump blocks B 1 and B 2 (fig. 2). The steps were reported unbroken in late fall 1973. Photograph taken January 25, 1974. First slumping and ground breakage on the blocks were reported during the summer of 1972. This indicates observable movement continuing over a period of 15 or 16 months.

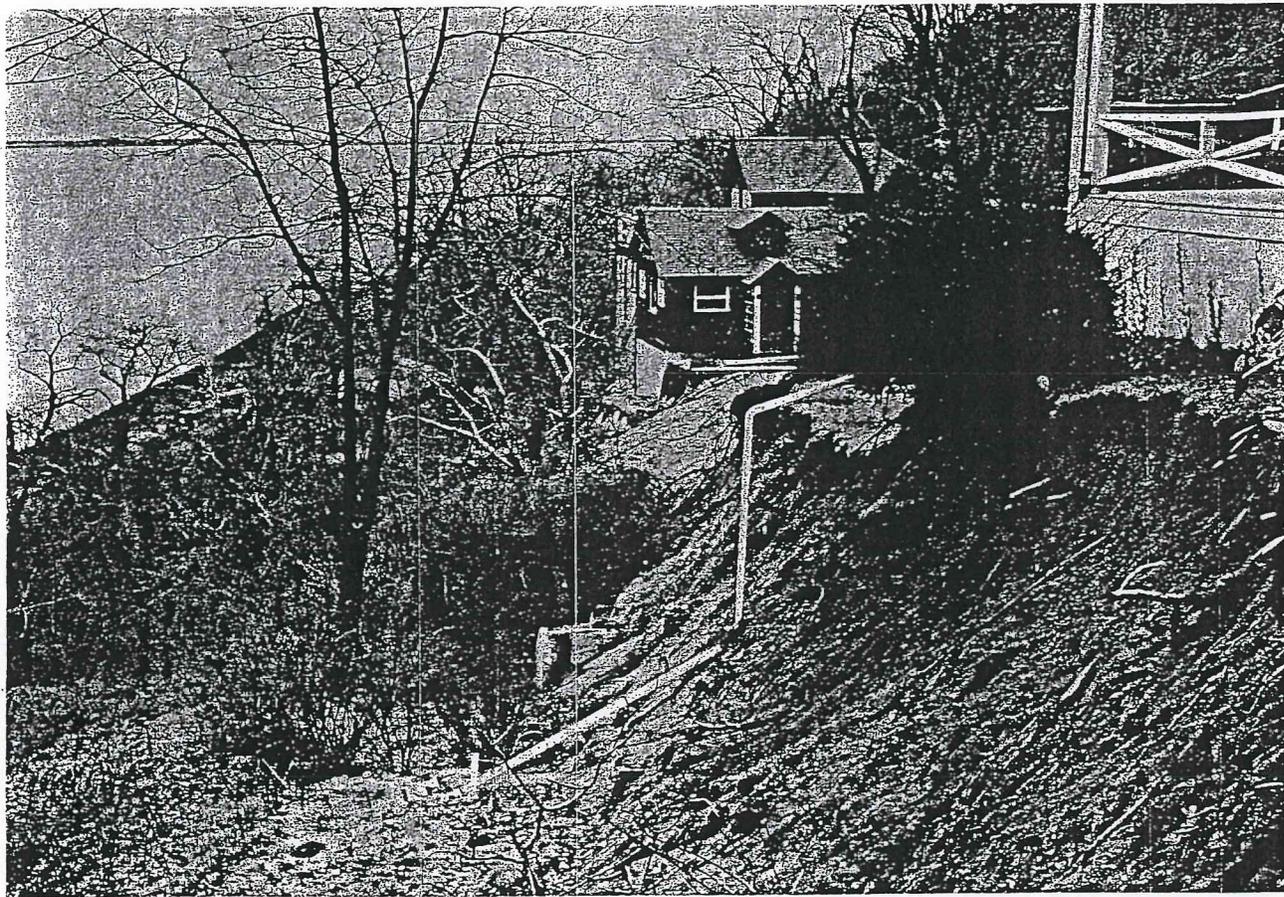
It appears that initial movement in blocks B 3 and B 4 probably was in the toe of the slope, possibly as a base failure (at least below the base of the old railroad bed). As material at the toe moved towards the bay, support was removed from material above, which followed in possibly several stages of slope failure before the present uppermost block began the slumping that has produced the 4- to 5-m (13- to 16-ft) scarp behind the houses.

FIGURE 17.—Looking east from the west end of slump block B 3. Scarp on right is rupture zone at top and rear of the block. Total vertical displacement is about 4 to 5 m (13 to 16 ft), most of which is reported to have occurred during a 3-month period in the summer and fall of 1972. The flat grassy area at bottom left was level with the lawn at upper right before failure. Photograph taken January 24, 1974. House in background is shown in figure 18.

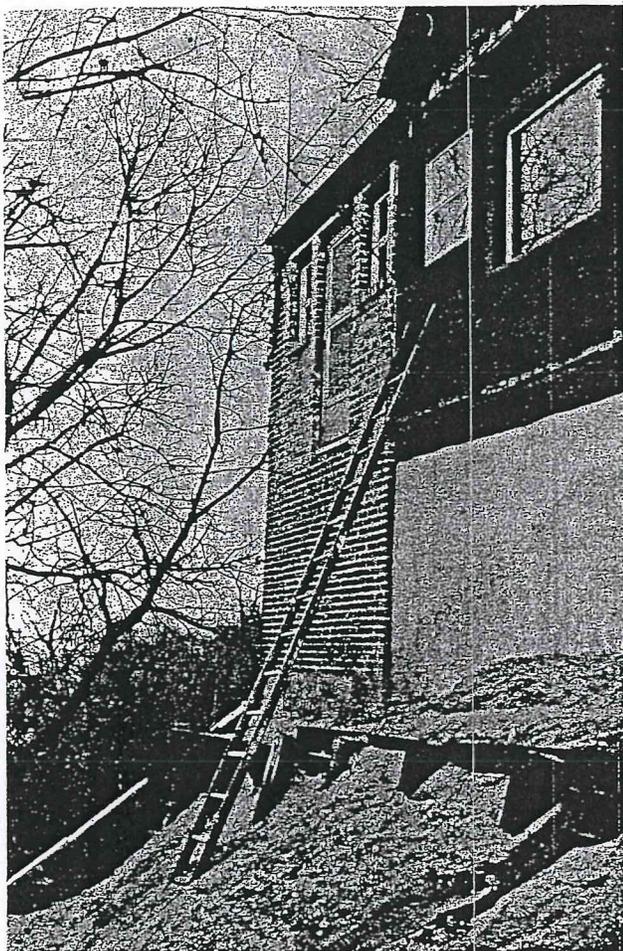
(fig. 18), one house has been moved back, another has had its foundation footing exposed, and two more are only a metre or two from the line of failure. This line of failure, at least in the upper exposed part, is in the loose-bedded sand of the upper Red Bank Sand. It may be an extension of the line of failure behind slump block B 1, which was mapped by the author in 1963-64 (Minard, 1969, pl. 1) as crossing Bayside Drive near the curve where the road abruptly turns south and uphill. No cracking was visible in the pavement at the time of that mapping. On June 7, 1973, however, cracking was visible in the edge of the road and through the stone wall. By January 25, 1974, this cracking in the pavement had multiplied and extended across

FIGURE 18.—House near east end of bank above block B 3, looking east. This is the house in the background of figure 17. The rear porch, which was attached to the house, collapsed when block B 3 dropped. Note position of door (watch that step!). Photograph taken January 24, 1974.

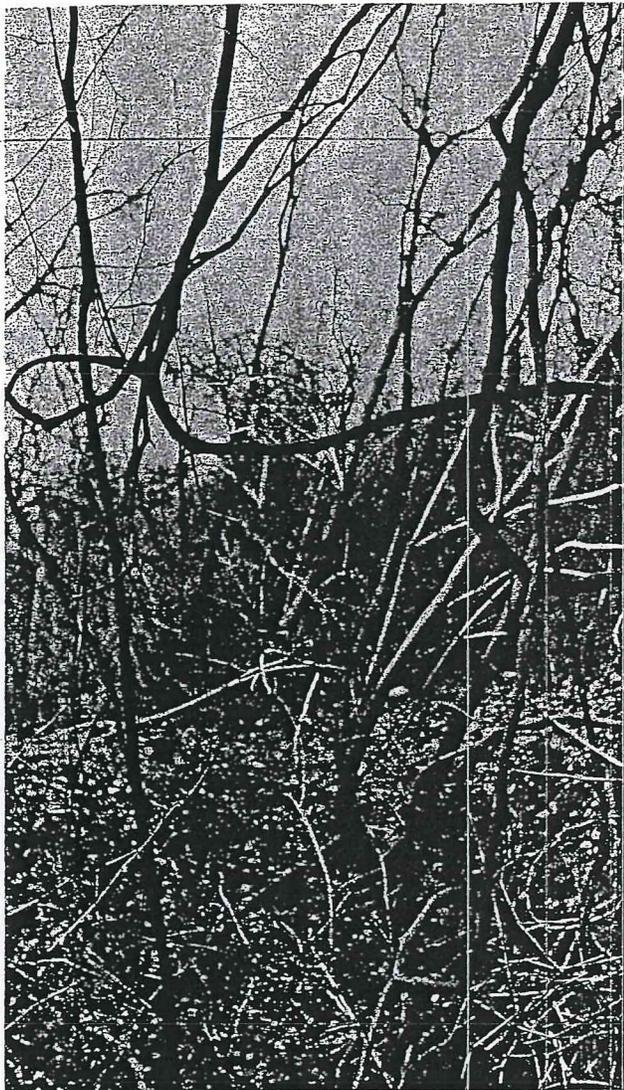
FIGURE 22.—View toward east showing tilted inner surfaces of block B 4 where slumped down from block B 3. (right of photograph). Notice that trees are tilted scarpward, illustrating rotational nature of the block; some vines appear to be stretched taut.
