Re: Geotechnical Engineering Report
Henry Hudson Trail-Atlantic Highlands Section

TRC Engineers, Inc. (TRC) is pleased to present this report that summarizes our conclusions and recommendations regarding the impact of existing surface conditions on the future improvements to the Henry Hudson Trail. Our work was performed in general accordance with the Request for Proposal PS#10-14 and the March 13, 2104 purchase order number 60746. Specifically the scope associated with this report was identified as Item 2 in the Request for Proposal.

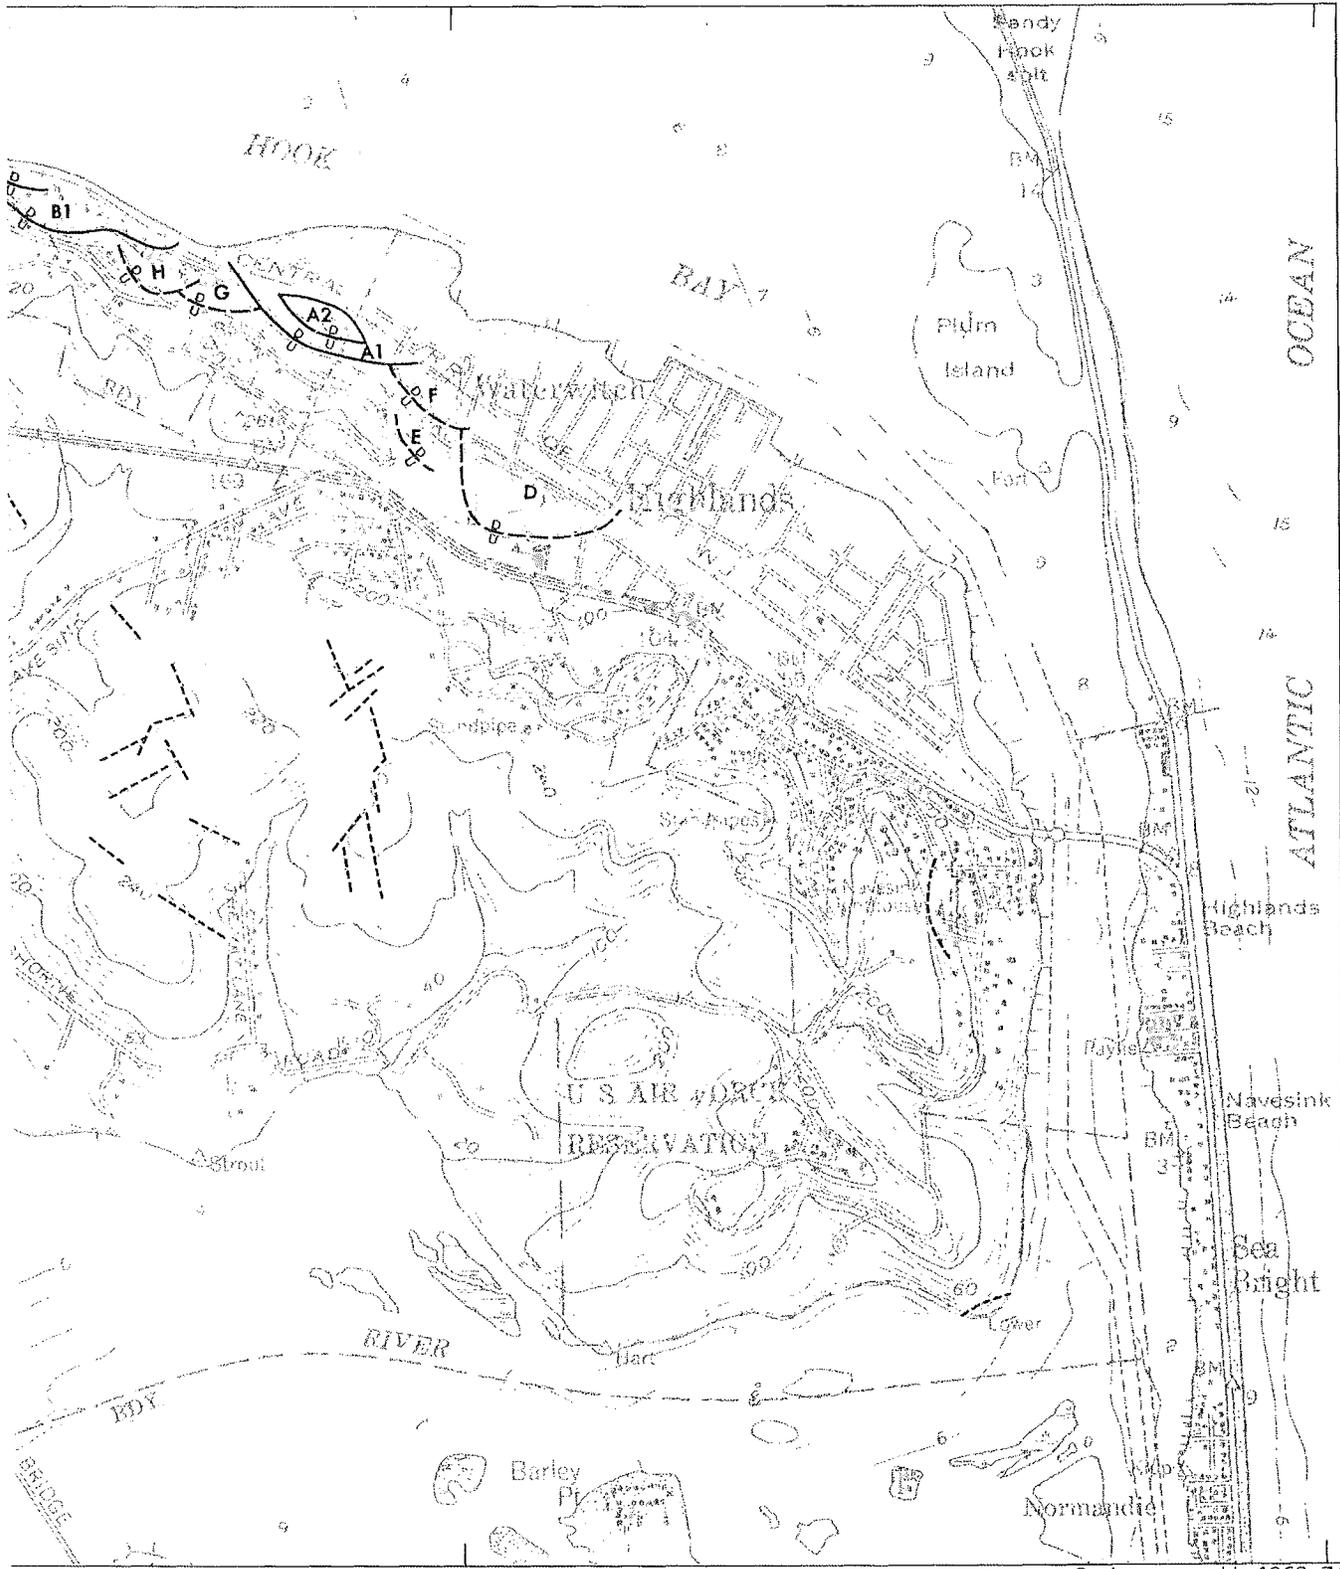
From about the summer of 1972 to the present (summer 1974), slumping has recurred in former slump blocks and has begun in steep slopes adjacent to older blocks. In this report, all slump blocks identified as definite, probable, and possible are outlined on a large-scale map (fig. 2); the physical settings

showing location of slump blocks and lineaments.

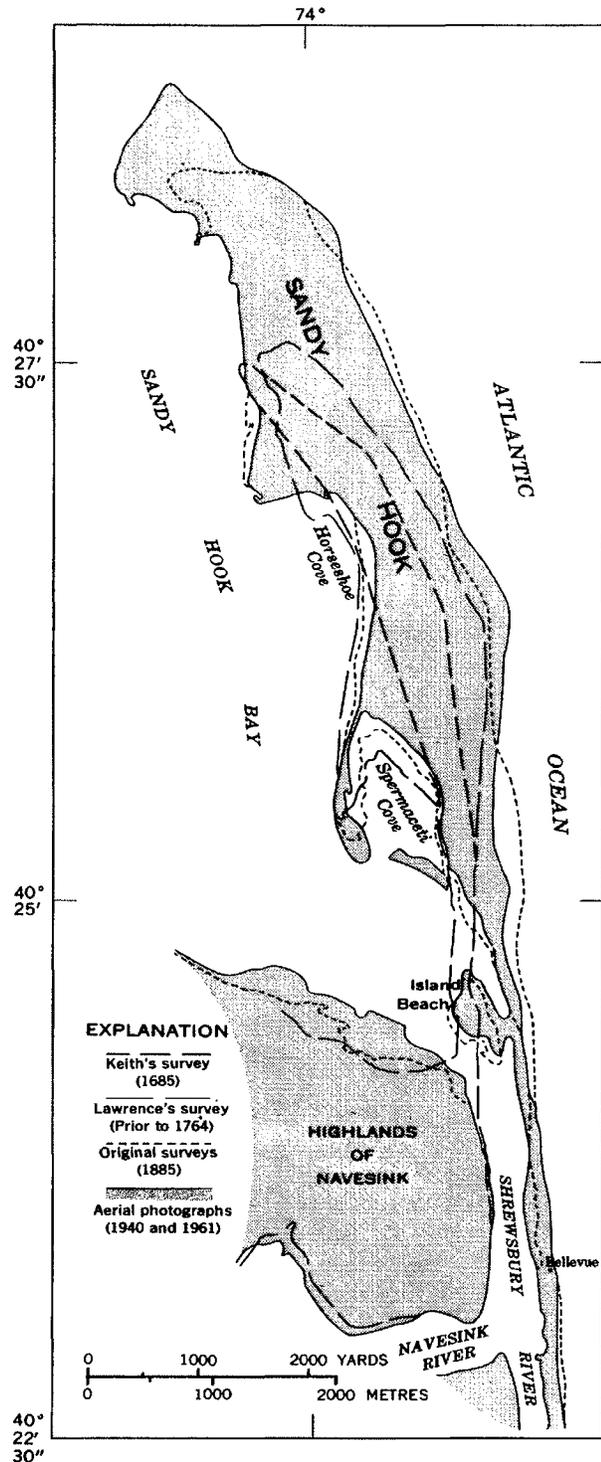
FIGURE 4.—Map of Sandy Hook spit showing progressive changes in shoreline during the period 1685-1961 (modified from Cook, 1885).

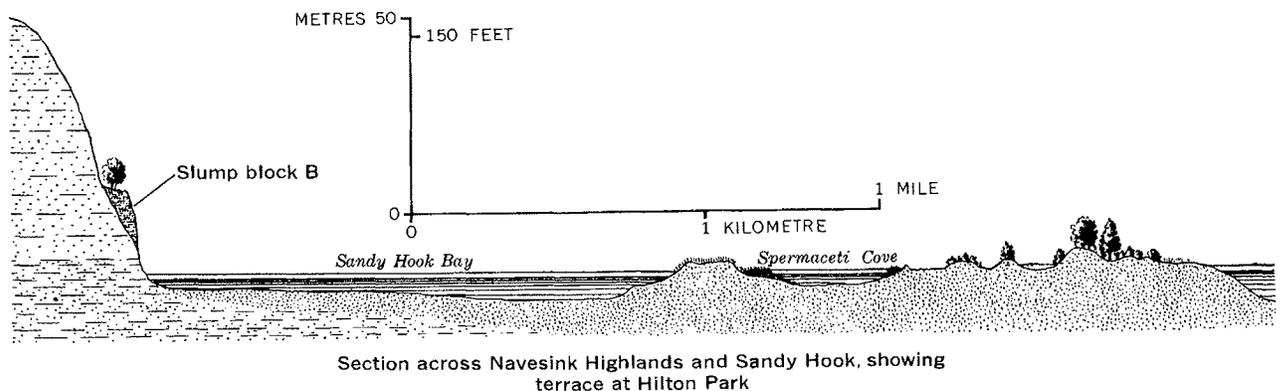
The different physical characteristics of what appears to be slump block B (fig. 2) was recognized by Merrill (in Cook, 1885, p. 76). In the figure titled "Section across Navesink Highlands and Sandy Hook," slump block B is shown as a terrace at Hilton Park, of different lithology than the bluff behind it (fig. 5). Shown in section with vertical exaggeration, the terrace seems to occupy a precarious position.

FIGURE 5.—Section showing what probably is slump block B as "a terrace at Hilton Park." From Cook, 1885, page 76.

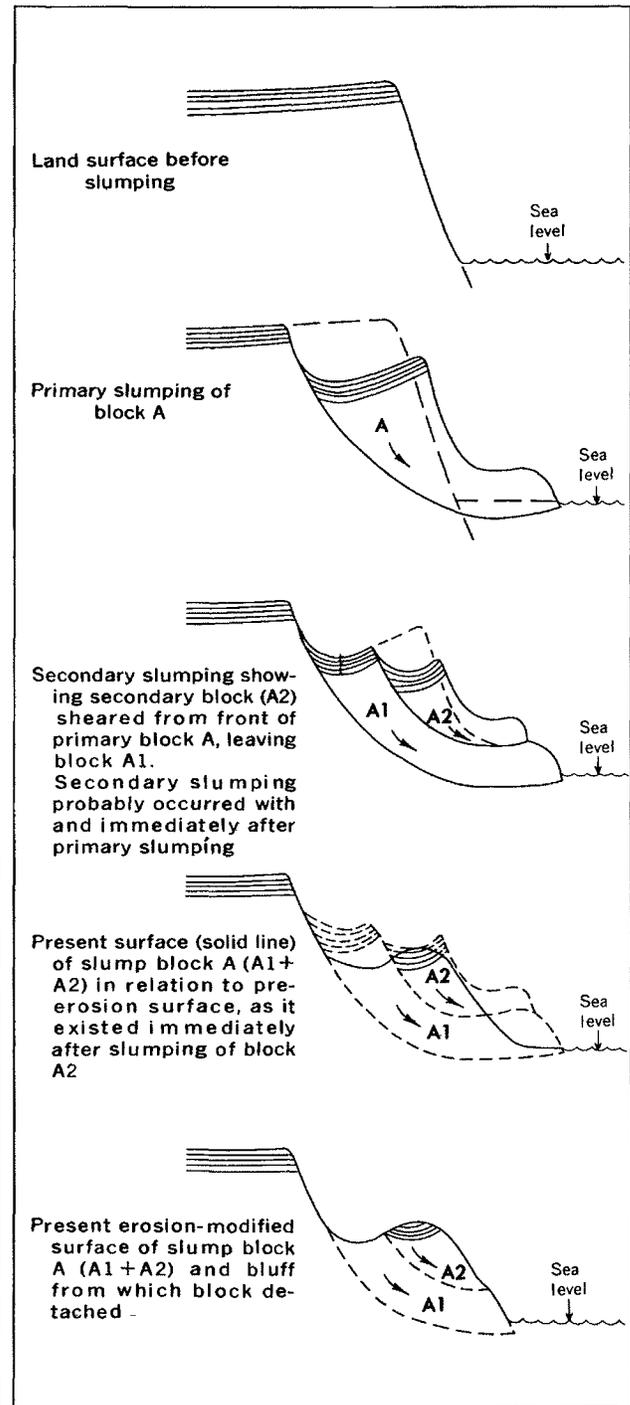
The history of slumping of a block is illustrated diagrammatically in figure 6. Also typical of many slump blocks is the secondary slumping that shears the primary block approximately in two and results in farther downward movement of the resultant outer block and additional rotation and tilting of beds in this block (fig. 7). More shearing and slumping in the secondary block is possible, particularly in unconsolidated sediments (Sharpe, 1938, figs. 8, 11, pls. IV B, VII A). Secondary shearing, however, is not characteristic of Reiche's Toreva block, which is considered a single large mass of unjostled material (Reiche, 1937, p. 538). A block diagram of a typical slump block, with names of the various parts, is shown in figure 8.

FIGURE 6.—Diagrammatic cross sections through the bluff at the location of slump block A (fig. 2), showing progressive steps in the history of the slumping.

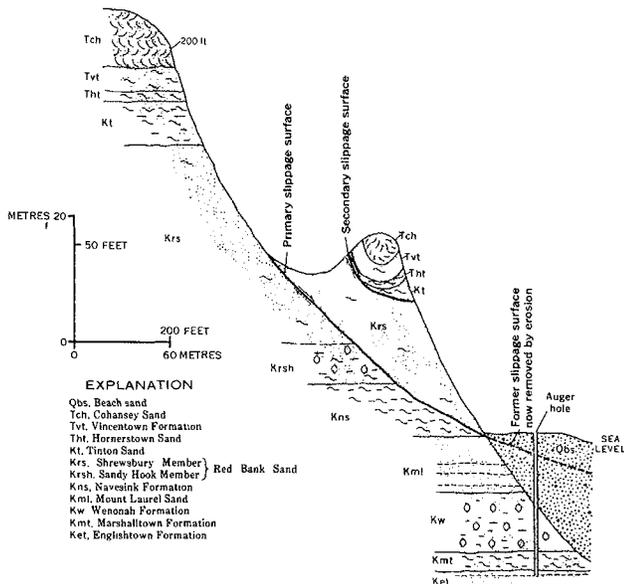
FIGURE 7.—Cross section (looking west) of slump block A in the bluff just west of Waterwitch (fig. 2). Vertical displacement of the small secondary block is about 85 feet. Vertical exaggeration $\times 4$. See figure 3 for explanation of lithologic symbols. Modified from Minard, 1969, figure 13.

The block has a secondary line of failure and slump block (A 2) near the middle of its cross section (fig. 7). The beds in block A 2, which originally were continuous with the beds at the top of the bluff 26 m (85 ft) above, have rotated from a nearly hori-

zontal attitude to about 40° inward and have been dragged on the inner surface to nearly 40° outward

(fig. 7). The primary (inner) slumping apparently was bottomed in the basal member of the Red Bank Sand and Navesink Formation. Secondary slumping was largely in the upper member of the Red Bank Sand. As can be seen in figure 2, several houses have been constructed on the block. A sand pit is present, from which much material has been removed in the past decade. This probably is beneficial in that it has taken much load off the block. It was in the sand pit that excellent exposures of the different lithic units made it easily possible to correlate these units with those from which they were separated in the bluff 26 m (85 ft) above.

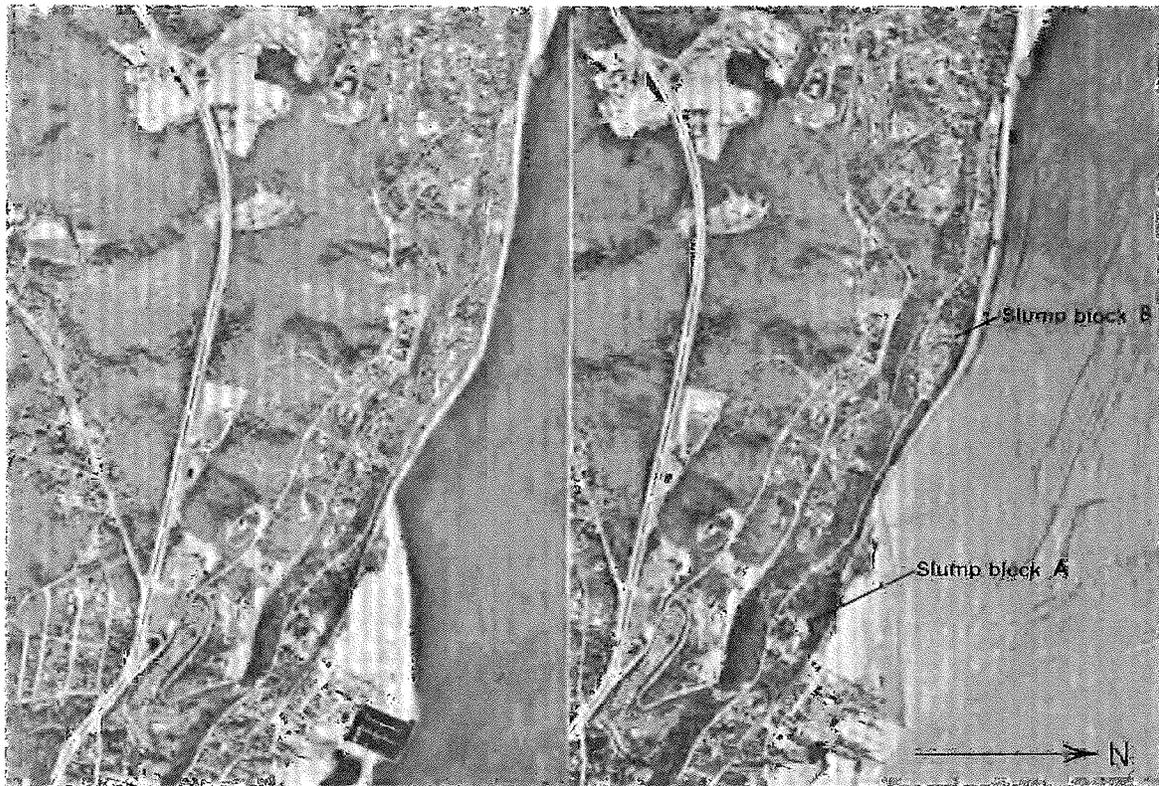
FIGURE 11.—Stereoscopic pair of vertical aerial photographs showing slump blocks A and B on the bluffs along the south side of Sandy Hook Bay. Scale 1:17,500. Photograph by Aero Service Corp., April 1961.

February 1974 (fig. 13). The gully in the scarp above and near the west end of block A is much deeper and wider at present than it appeared on the stereoscopic pair of aerial photographs taken in 1961 (fig. 11).

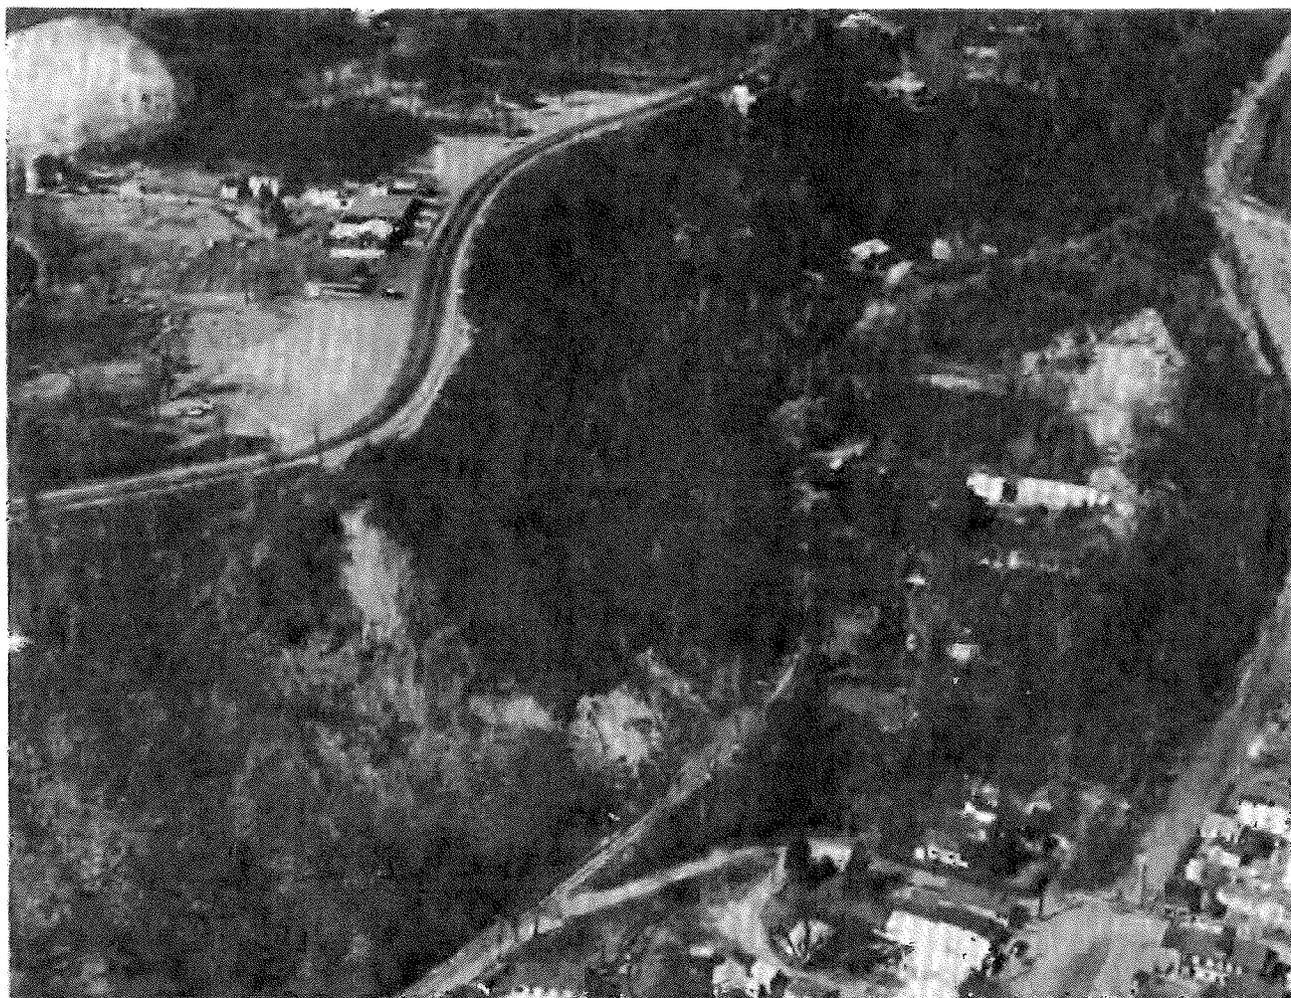
FIGURE 12.—Oblique aerial (helicopter) photograph (looking west) showing extent of surface erosion on the bluff face (center of photograph) on March 16, 1966. Vertical distance from road on top of bluff to road at base of bluff is about 60 m (200 ft). Slump block A is on right part of photograph. Compare extent of slope erosion with that shown in figure 13. The present front of block A lies about 100 m (several hundred feet) bayward (to the right) from its pre-slump position in the bluff.

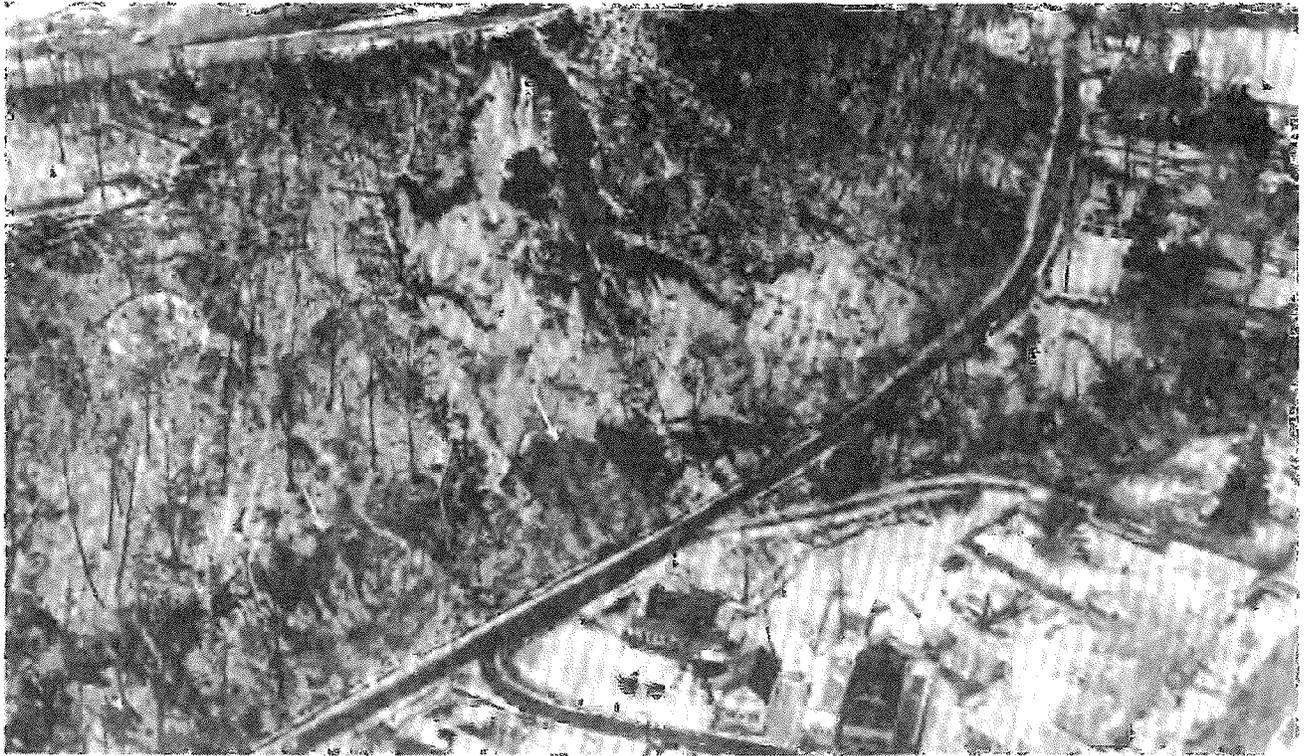
FIGURE 13.—Oblique aerial (helicopter) photograph (looking west) showing extent of surface erosion on the bluff face (center of photograph) on February 13, 1974. Vertical distance from road at top of bluff to road at base of bluff is about 60 m (200 ft). Inner part of slump block A is at far right; scarp is above and left of it. Compare extent of slope erosion with that shown on figure 12, nearly 8 years earlier. Erosion has extended upward, nearly undercutting the road, and laterally. Erosion has cut back into the face of the bluff, as is indicated by the steeper banks bordering the edges of the scar.
