# Slump Blocks in the Atlantic Highlands of New Jersey

By JAMES P. MINARD

GEOLOGICAL SURVEY PROFESSIONAL PAPER 898

*A description of slump blocks and slumping  
in the hills of the northeastern  
New Jersey Coastal Plain, and a  
discussion of their potential  
as geologic hazards*

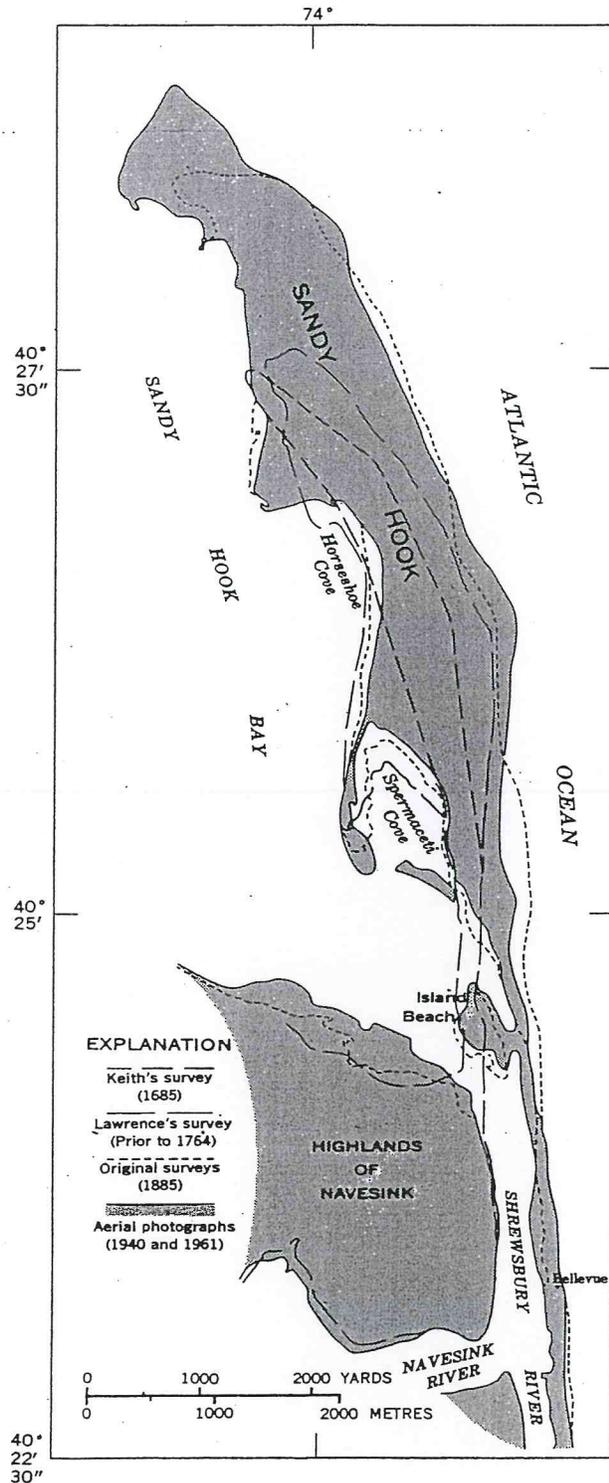
FIGURE 4.—Map of Sandy Hook spit showing progressive changes in shoreline during the period 1685-1961 (modified from Cook, 1885).

closed the eastern passage [through the present bar near Bellevue, fig. 4] or old Shrewsbury inlet in 1810. From this time on the outer beach continued and the Navesink River flowed through its present outlet [north and northwest, fig. 4] until 1830 or 1831, when a breach was made in the sand reef and the second Shrewsbury inlet was formed. Shortly after a bar formed across the present mouth of the river and connected Sandy Hook with the mainland, just north of Highlands, by way of Island Beach [fig. 4]. About 1835 the residents of the vicinity undertook to open a channel through the bar, and after much labor cut a ditch through it, which was gradually widened and deepened by the tides until it became navigable. The second inlet opened in 1830 or 1831, and closed about 1840. The third opened in 1837 or 1838, and for a time there were two navigable inlets—the second or more southerly being most used. The east inlet closed in the latter part of 1848. Within the past 35 years the sea has made occasional breaches in the strip of beach under discussion [the offshore bar that presently (1974) connects Sandy Hook with the mainland in the vicinity of Long Branch adjacent to the south of the map area [fig. 4], but the efforts of property owners, and especially of the railroad company, since the building of the road, have prevented them from attaining any magnitude.

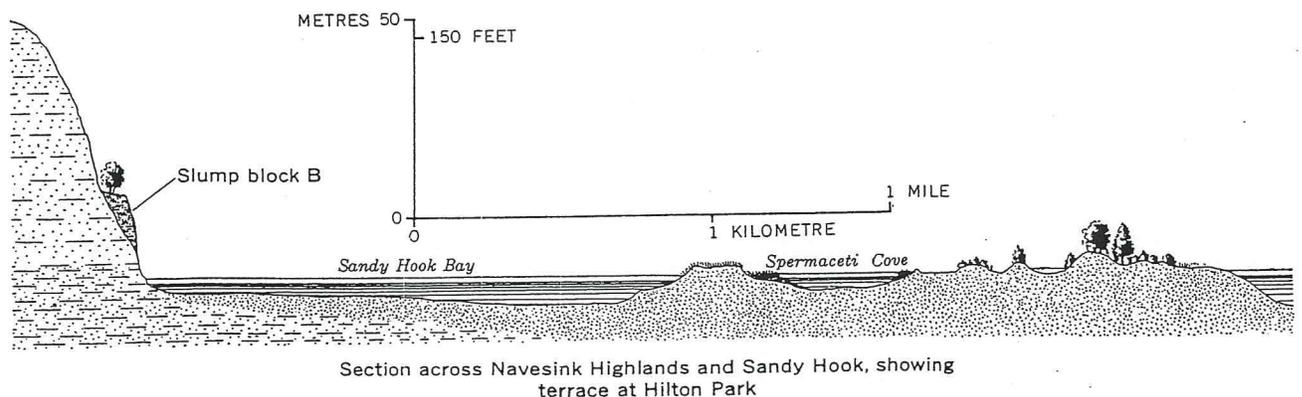
The different physical characteristics of what appears to be slump block B (fig. 2) was recognized by Merrill (in Cook, 1885, p. 76). In the figure titled "Section across Navesink Highlands and Sandy Hook," slump block B is shown as a terrace at Hilton Park, of different lithology than the bluff behind it (fig. 5). Shown in section with vertical exaggeration, the terrace seems to occupy a precarious position.

FIGURE 5.—Section showing what probably is slump block B as "a terrace at Hilton Park." From Cook, 1885, page 76.

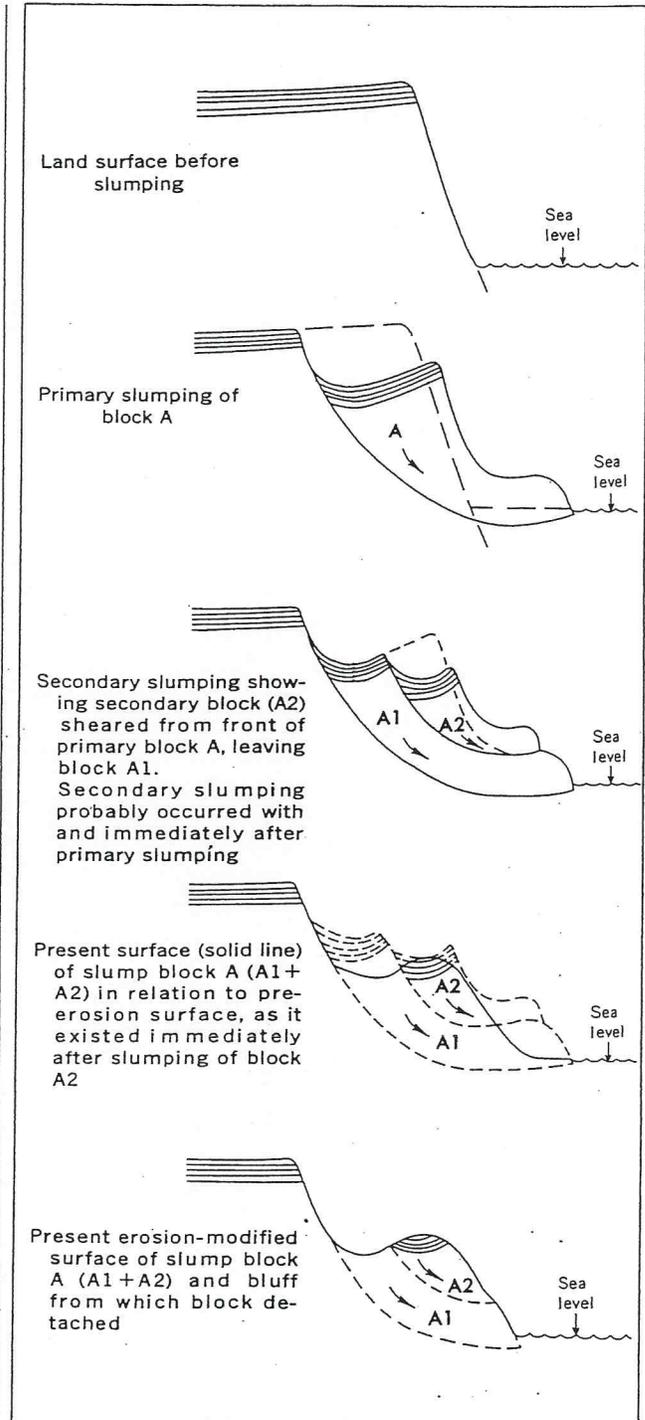
The history of slumping of a block is illustrated diagrammatically in figure 6. Also typical of many slump blocks is the secondary slumping that shears the primary block approximately in two and results in farther downward movement of the resultant outer block and additional rotation and tilting of beds in this block (fig. 7). More shearing and slumping in the secondary block is possible, particularly in unconsolidated sediments (Sharpe, 1938, figs. 8, 11, pls. IV B, VII A). Secondary shearing, however, is not characteristic of Reiche's Toreva block, which is considered a single large mass of unjostled material (Reiche, 1937, p. 538). A block diagram of a typical slump block, with names of the various parts, is shown in figure 8.

FIGURE 6.—Diagrammatic cross sections through the bluff at the location of slump block A (fig. 2), showing progressive steps in the history of the slumping.

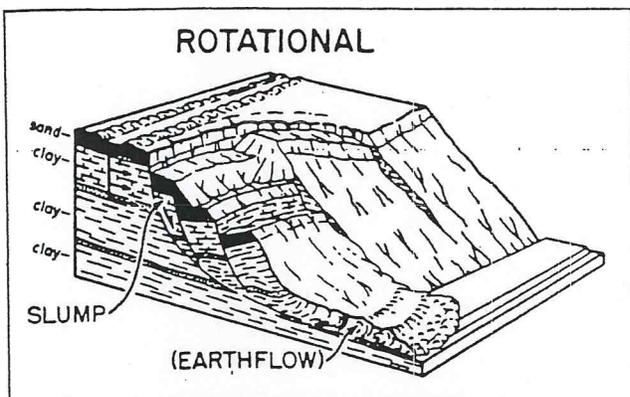
blocks, which are farther from the point of detachment, usually have a steeper dip than similar beds in the inner or primary block (fig. 9).

FIGURE 9.—Block diagram showing steeper scarpward tilt of upper beds in outer blocks (from Varnes, 1958, pl. 1).

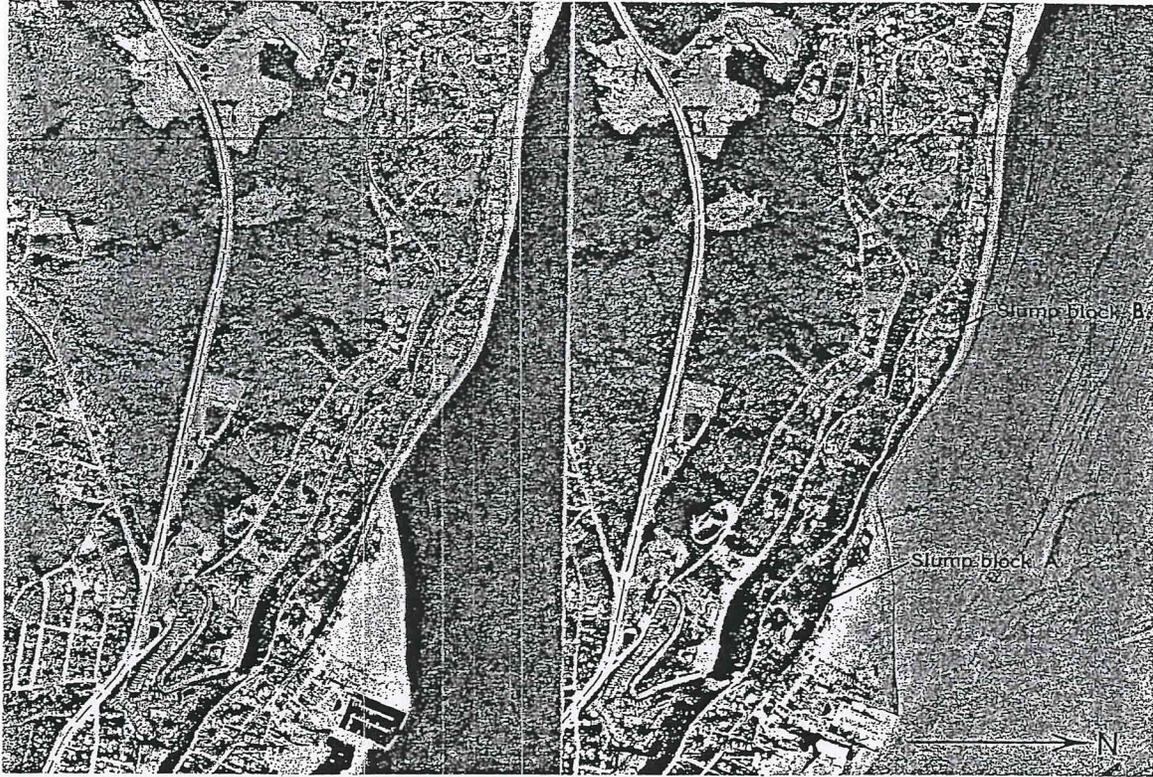
FIGURE 11.—Stereoscopic pair of vertical aerial photographs showing slump blocks A and B on the bluffs along the south side of Sandy Hook Bay. Scale 1:17,500. Photograph by Aero Service Corp., April 1961.

February 1974 (fig. 13). The gully in the scarp above and near the west end of block A is much deeper and wider at present than it appeared on the stereoscopic pair of aerial photographs taken in 1961 (fig. 11).

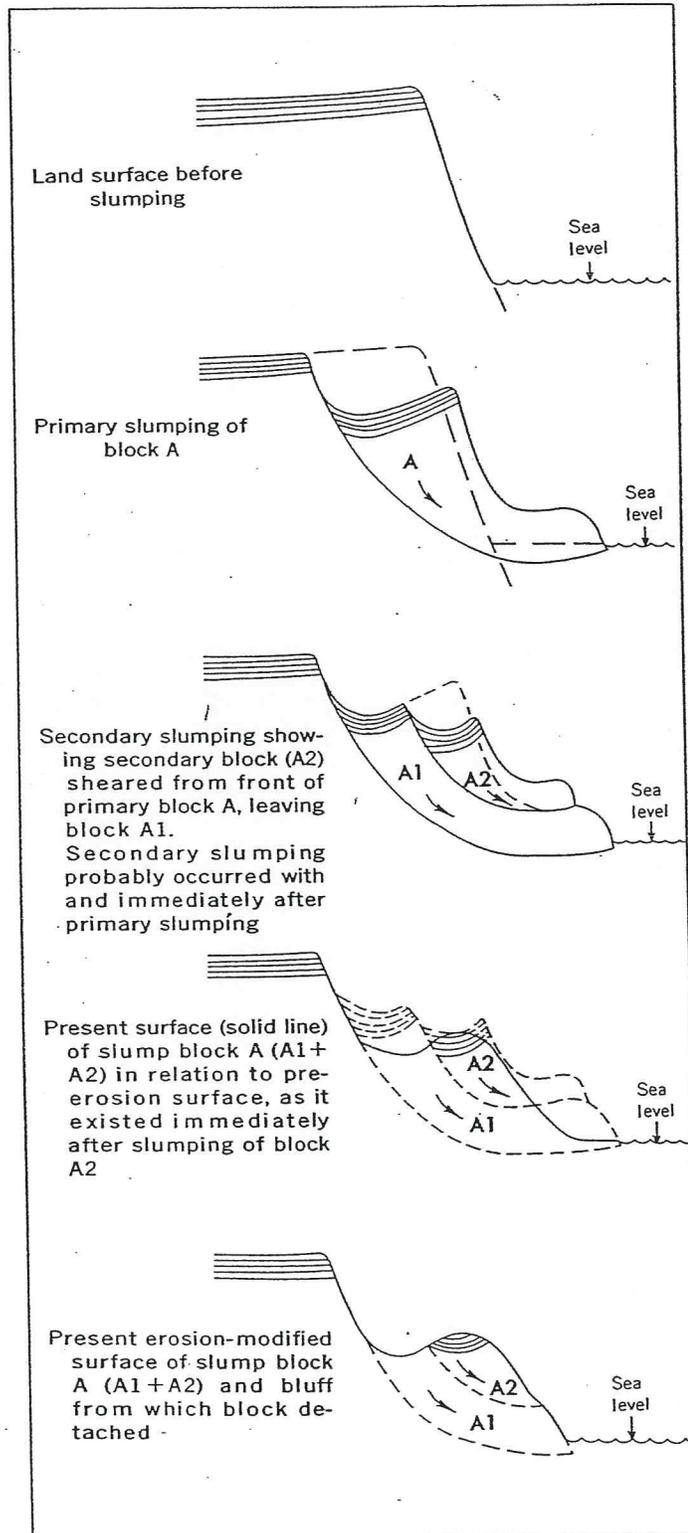
Historic Stages of Slump Blocking at Eastpointe and Mt. Mitchill Scenic Overlook Park  
 (Reproduced from Minard 1974, Figure 6 and displayed in the Park)

FIGURE 6.—Diagrammatic cross sections through the bluff at the location of slump block A (fig. 2), showing progressive steps in the history of the slumping.
